# troubleshooting Abbott Alinity m assay failures and error codes

**Author:** BenchChem Technical Support Team. **Date:** December 2025

## Abbott Alinity m Technical Support Center

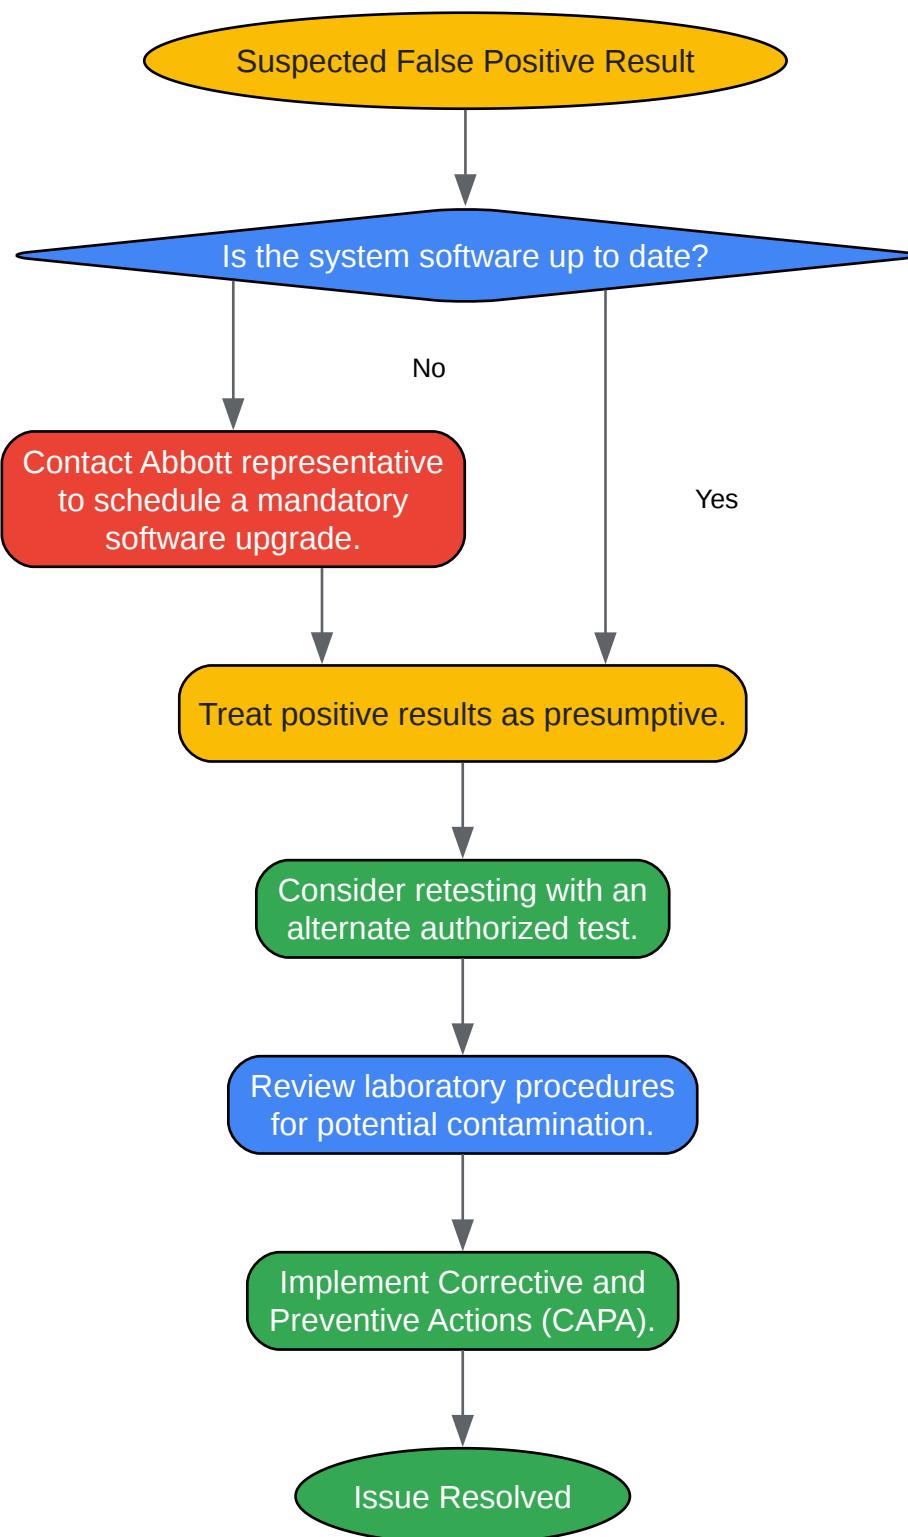
False positive results can arise from several factors, including software issues and procedural errors. A notable cause has been a software problem that could lead to overflow between sample wells during processing.<sup>[7][8][9]</sup>

Caption: Troubleshooting workflow for suspected false positive results.

- Quarantine Results: Immediately quarantine any suspected false positive results and the associated samples.
- Verify Software Version: Check the current software version on your Alinity m system. Cross-reference this with any recent communications from **Abbott** regarding software updates.

- Retest with an Alternative Method: If a software issue is not the immediate suspect, or as a confirmatory step, retest the original patient specimen using a different authorized molecular diagnostic test.

- Review Run Data: Analyze the amplification curves for any abnormalities, such as non-sigmoidal shapes, which could indicate a false positive.
- Assess for Cross-Contamination: Review sample handling and loading procedures to identify any potential for well-to-well contamination.

- Contact **Abbott** Support: If the issue persists or is confirmed to be related to a known problem, contact **Abbott** Technical Support for further guidance.

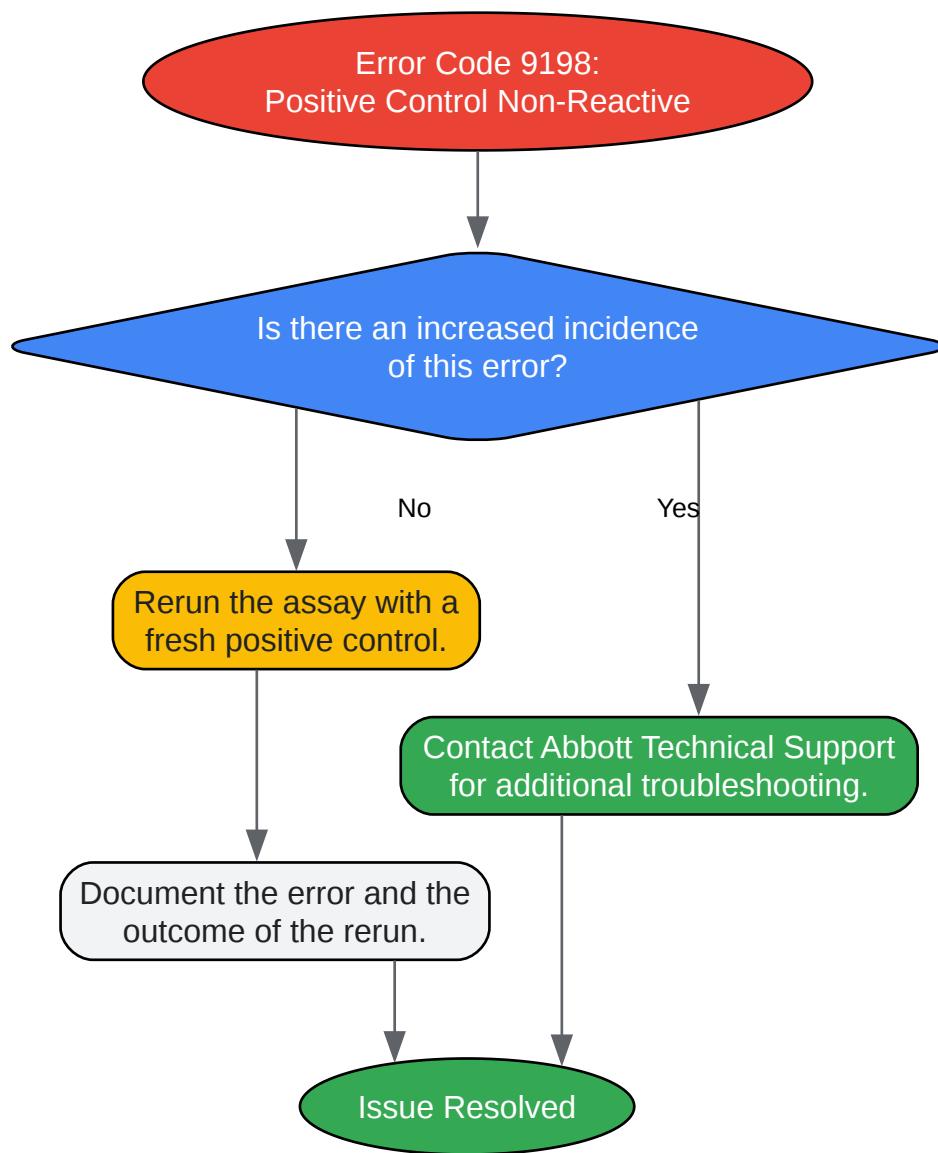
This error indicates that the positive control in an assay run did not produce the expected reactive result, invalidating the run. A key identified cause for this error, particularly with the Alinity m HR HPV and STI AMP Kits, is the leaching of iron from the lysis transfer pump into the Alinity m Lysis Solution.[\[5\]](#)[\[6\]](#)[\[10\]](#)

Caption: Troubleshooting workflow for Error Code 9198.

- Invalidate Run: Do not report any patient results from a run where the positive control failed.
- Inspect Reagents: Ensure that the correct assay-specific positive control was used and that it has not expired.

- Prepare a Fresh Control: If possible, prepare a fresh positive control from a new vial or lot number.
- Rerun the Assay: Repeat the assay with the fresh positive control.
- Monitor Error Frequency: If you experience an increased incidence of Error Code 9198, it may be indicative of the iron leaching issue.
- Contact **Abbott** Support: For persistent or frequent occurrences of this error, contact **Abbott** Technical Support for further investigation and potential service of the lysis transfer pump.[\[5\]](#) [\[6\]](#)

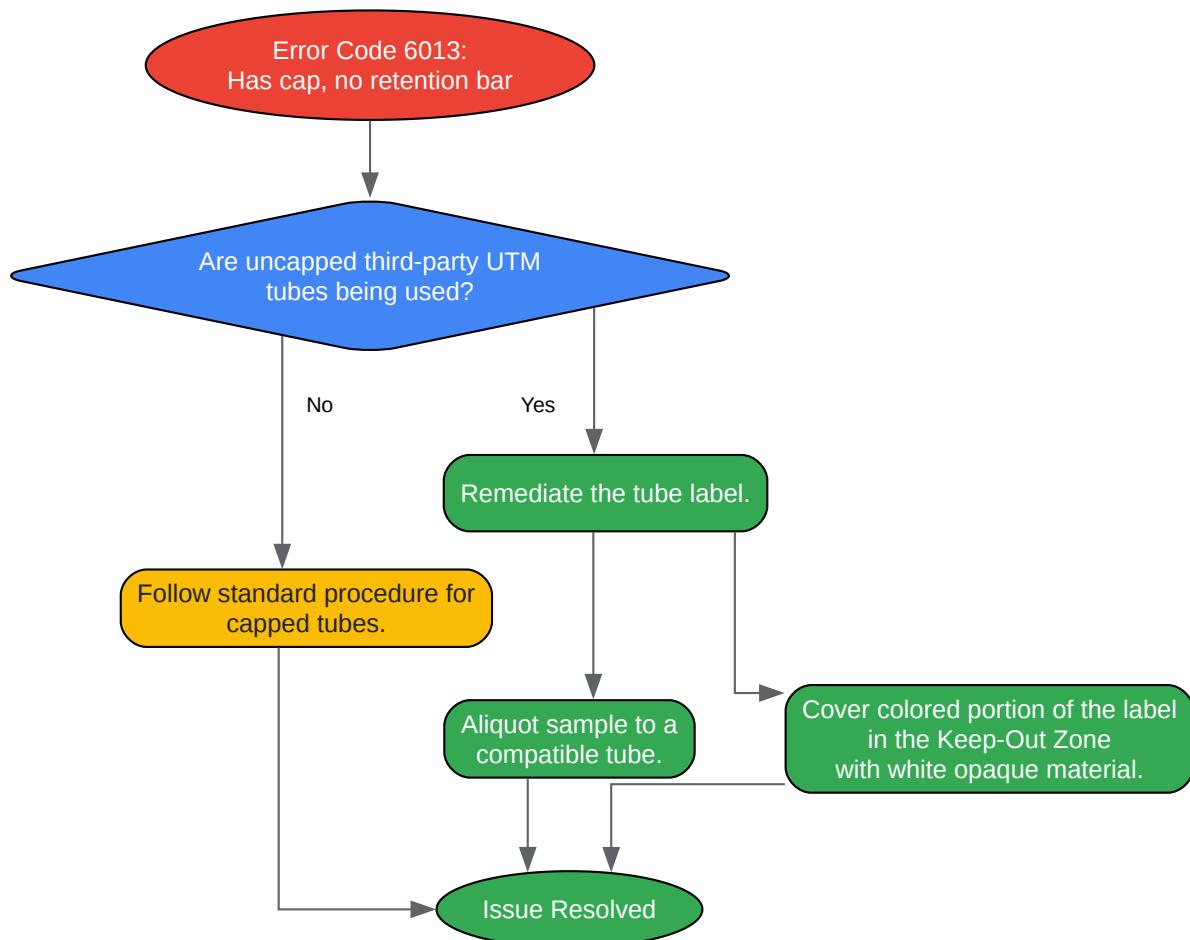
This error can be incorrectly generated when using certain third-party Universal Transport Medium (UTM) tubes. The system's camera may falsely detect a cap due to colors other than black or white on the tube label within the "Keep-Out Zone".[\[11\]](#)

Caption: Troubleshooting workflow for Error Code 6013.

- Aliquot the sample: Transfer the sample to another tube that is permitted by the assay's package insert and ensure the tube label meets the required specifications.[\[11\]](#)
- Cover the label: Use white opaque material (e.g., a white sticker) to cover the colored portion of the tube label that falls within the "Keep-Out Zone."[\[11\]](#)

- Contact tube manufacturer: Reach out to the manufacturer of the problematic tubes to inquire about alternative options that are compatible with the Alinity m system's detection mechanism.[\[11\]](#)
