# Technical Support Center: Long-Term Stability of 7-Mercaptoheptanoic Acid Modified Surfaces

**Author:** BenchChem Technical Support Team. **Date:** April 2026

Compound Name: 7-Mercaptoheptanoic acid

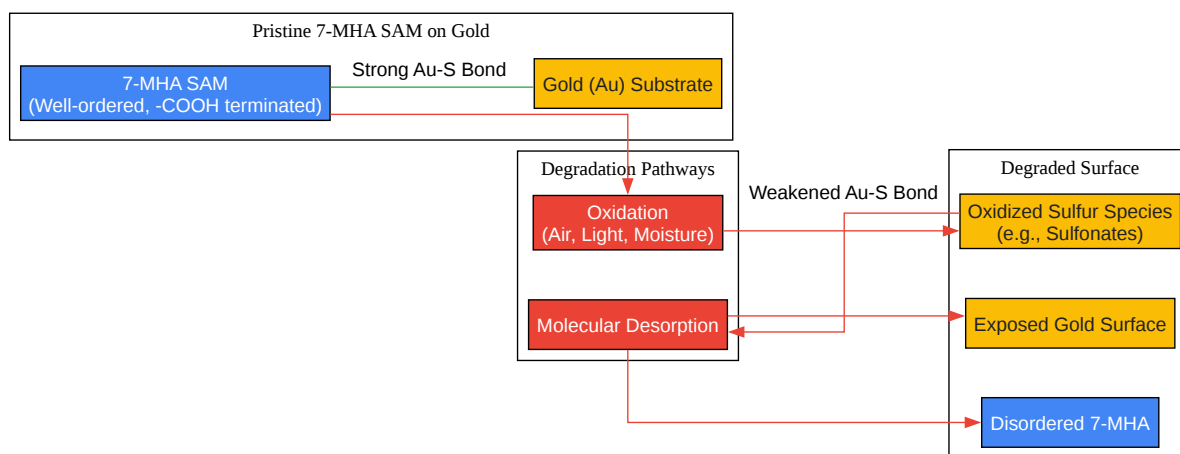
Degradation pathway of a 7-MHA modified surface.

Question	Answer
Why is the contact angle of my 7-MHA surface changing over time?	A changing contact angle is a primary indicator of SAM degradation. For -COOH terminated SAMs, an increase in the water contact angle over time suggests desorption of the hydrophilic 7-MHA molecules, exposing the underlying, more hydrophobic gold substrate.[1] This can occur even under ambient laboratory conditions.
What are the main causes of 7-MHA SAM degradation?	The primary degradation pathway for alkanethiol-based SAMs on gold, including 7-MHA, is the oxidation of the gold-thiolate bond. [2] This process is accelerated by exposure to ambient conditions such as air (oxygen and ozone), light (UV radiation), and moisture.[2] This oxidation can lead to the desorption of the 7-MHA molecules from the gold surface.
My XPS data shows a change in the Sulfur (S 2p) spectrum. What does this mean?	Changes in the S 2p spectrum are a direct indication of chemical modifications to the sulfur headgroup. A pristine gold-thiolate bond typically shows a primary S 2p <sub>3/2</sub> peak around 162 eV. The appearance of higher binding energy peaks (e.g., 163-164 eV and above) suggests the oxidation of the sulfur to sulfonate or other oxidized species.[2] This oxidation weakens the bond to the gold surface, leading to instability.

AFM images of my 7-MHA surface show increased roughness and pits. What is happening?	Increased surface roughness and the appearance of pits in AFM images are physical evidence of SAM degradation.[1] These features indicate the desorption of 7-MHA molecules, creating vacancies in the monolayer and exposing the underlying gold substrate. Over time, this can lead to a significant loss of the SAM.

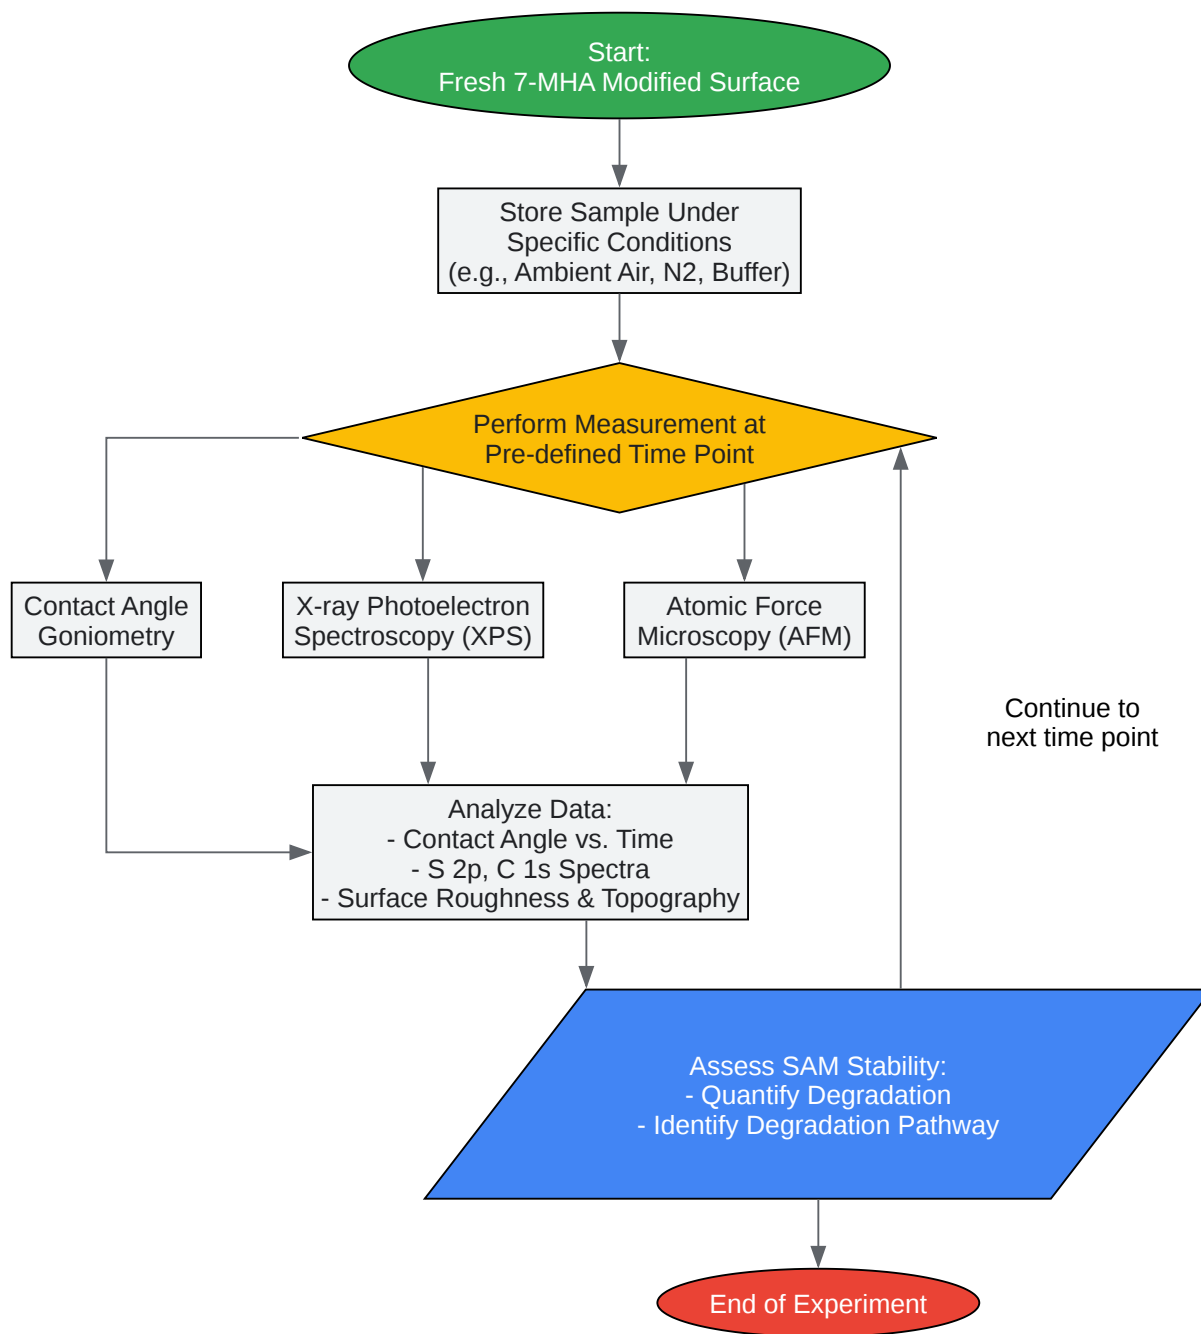
Experimental workflow for assessing SAM stability.
