M-CDEA Cured Systems: Technical Support & Troubleshooting Guide

Welcome to the technical support center for M-CDEA (4,4'-methylene-bis(3-chloro-2,6-diethylaniline)) cured casting systems. This guide is designed for researchers, scientists, and development professionals to diagnose, prevent, and resolve common defects encountered during the casting of high-performance polyurethane and epoxy parts using M-CDEA as a curative. Our approach is rooted in understanding the fundamental chemical and physical processes that govern the curing reaction and final part quality.

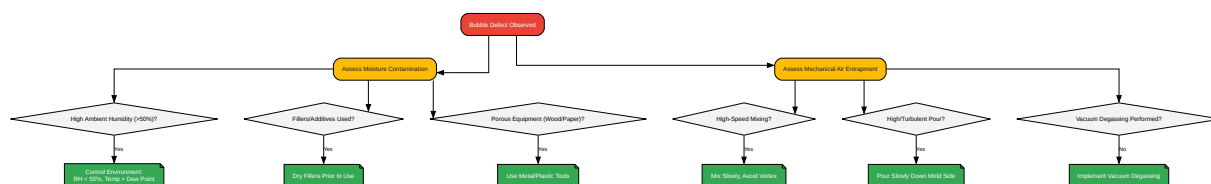
Troubleshooting Workflow: Bubble Formation

Below is a logical workflow to diagnose the source of bubbles in your casting.

Caption: Diagnostic workflow for identifying and resolving bubble defects.

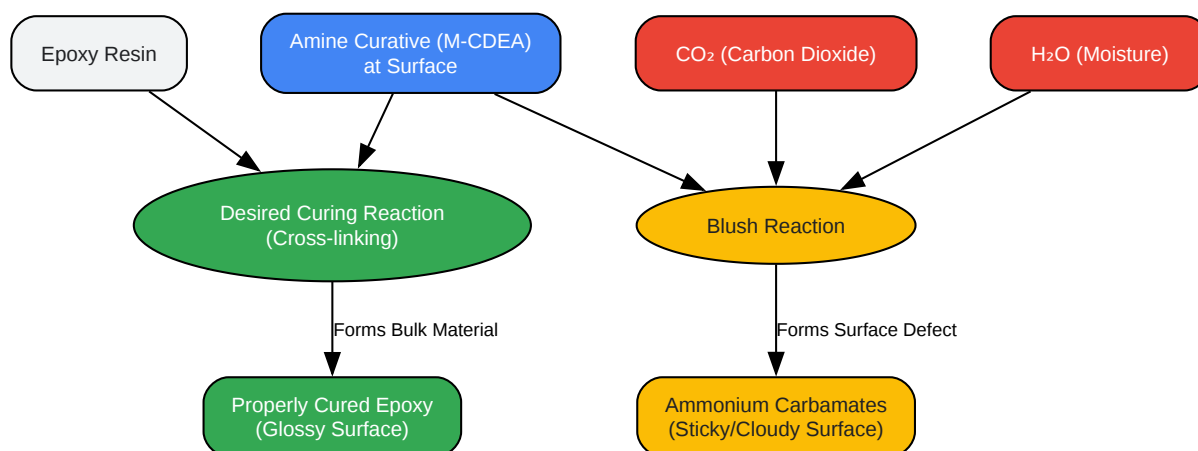
Chemical Pathway: Amine Blush Formation

The diagram below illustrates the competing reactions at the surface of an amine-cured epoxy.

Caption: Competing reactions leading to proper cure versus amine blush.

- Mechanism: Amine blush is primarily caused by a reaction between the amine curative, atmospheric moisture (H₂O), and carbon dioxide (CO₂).^{[7][11]} Amines are hygroscopic and attract moisture from the air.^[6] This moisture allows the amine groups at the surface to react with CO₂ to form carbamate salts.^[10] These salts deposit on the surface, creating a waxy, sticky, or cloudy film.^{[6][7]}
