# Technical Support Center: Troubleshooting High Background in GRP ELISA Assays

Compound Name: GRP (porcine) (trifluoroacetate salt)

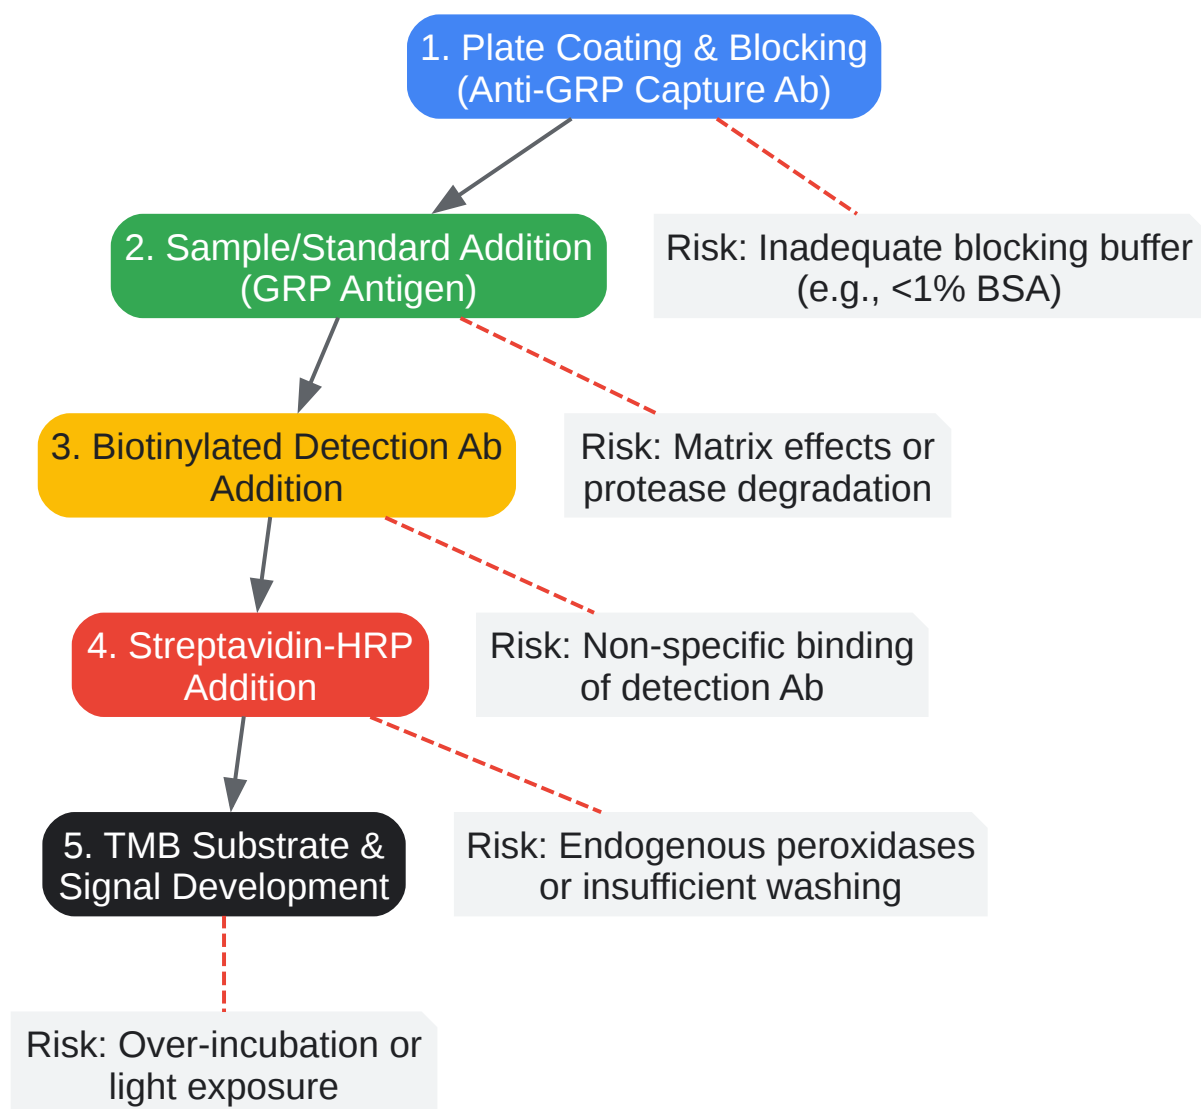
Caption: GRP ELISA workflow highlighting critical steps where high background noise is commonly introduced.

- **Hydrophobic Adsorption & Inadequate Blocking:** Polystyrene microplates are highly hydrophobic. If the blocking buffer (e.g., BSA or casein) does not fully saturate the unbound surface area, the biotinylated detection antibody or the Streptavidin-HRP conjugate will non-specifically adsorb to the well floor[1][2].
- **Catalytic Turnover from Contamination:** The TMB (3,3',5,5'-Tetramethylbenzidine) substrate is highly sensitive. Poor-quality water used to prepare wash buffers can introduce trace metal ions or microbial peroxidases that catalyze TMB independently of your target analyte[3][4].
- **Incomplete Wash Mechanics:** The most common cause of high background is residual, unbound Streptavidin-HRP. Without sufficient shear force and soak times during the wash steps, unbound conjugate remains trapped in the well corners, leading to false-positive signal amplification[2][5].

- **Sample Addition:** Add 100 µL of standards, blanks (Standard Diluent only), and samples to the pre-coated microtiter plate. **Validation Check:** The blank wells will validate whether background is reagent-derived or sample-derived.
- **Incubation:** Cover with an adhesive plate sealer and incubate at 37°C for 60–90 minutes (refer to specific kit guidelines)[6].
- **Primary Wash (Critical Step):** Aspirate the liquid. Wash the plate 3 to 4 times with 300 µL of 1X Wash Buffer per well. **Crucial:** Allow a 30-second to 1-minute soak time during each wash cycle to break hydrophobic bonds[2][6].
- **Detection Antibody:** Add 100 µL of Biotinylated Anti-GRP Antibody to each well. Incubate at 37°C for 60 minutes.
- **Secondary Wash:** Repeat the wash step 3 to 4 times, maintaining the 30-second soak.

- **Conjugate Addition:** Add 50  $\mu$ L to 100  $\mu$ L of Streptavidin-HRP to each well. Incubate at 37°C for 30–60 minutes[6].
- **Tertiary Wash (Maximum Stringency):** Wash the plate 5 times with 300  $\mu$ L Wash Buffer. Complete removal of liquid at this step is essential. After the final wash, invert the plate and blot vigorously against clean, absorbent paper towels to remove residual droplets[6].
- **Signal Development:** Add 100  $\mu$ L of TMB Substrate. Incubate in the dark at 37°C for 10–25 minutes. Watch the plate: if the blank wells turn blue within 5 minutes, stop the reaction early.
- **Stop & Read:** Add 50  $\mu$ L of acidic Stop Solution. The color will shift from blue to yellow. Read the OD immediately at 450 nm[6].

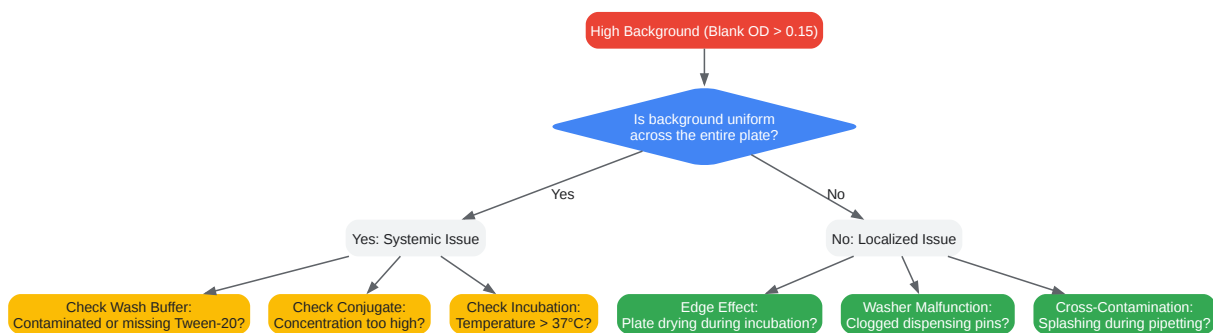
Caption: Logical decision tree for diagnosing uniform vs. localized high background in ELISA plates.

Q: My blank OD is  $> 0.2$ , but my standard curve looks fine. What is causing this? A: If your standard curve is linear but shifted upward, the issue is systemic non-specific binding. This is usually caused by an inadequate blocking buffer or an overly concentrated Streptavidin-HRP conjugate. Try increasing the blocking solution concentration (e.g., from 1% to 2% BSA) or adding 0.05% Tween-20 to the blocker to disrupt weak hydrophobic interactions[1]. Alternatively, titrate your secondary conjugate to a higher dilution[7].
