troubleshooting dull copper plating from a KCu(CN)2 bath

Technical Support Center: KCu(CN)2 Copper Plating

Troubleshooting Guide: Dull Copper Deposits

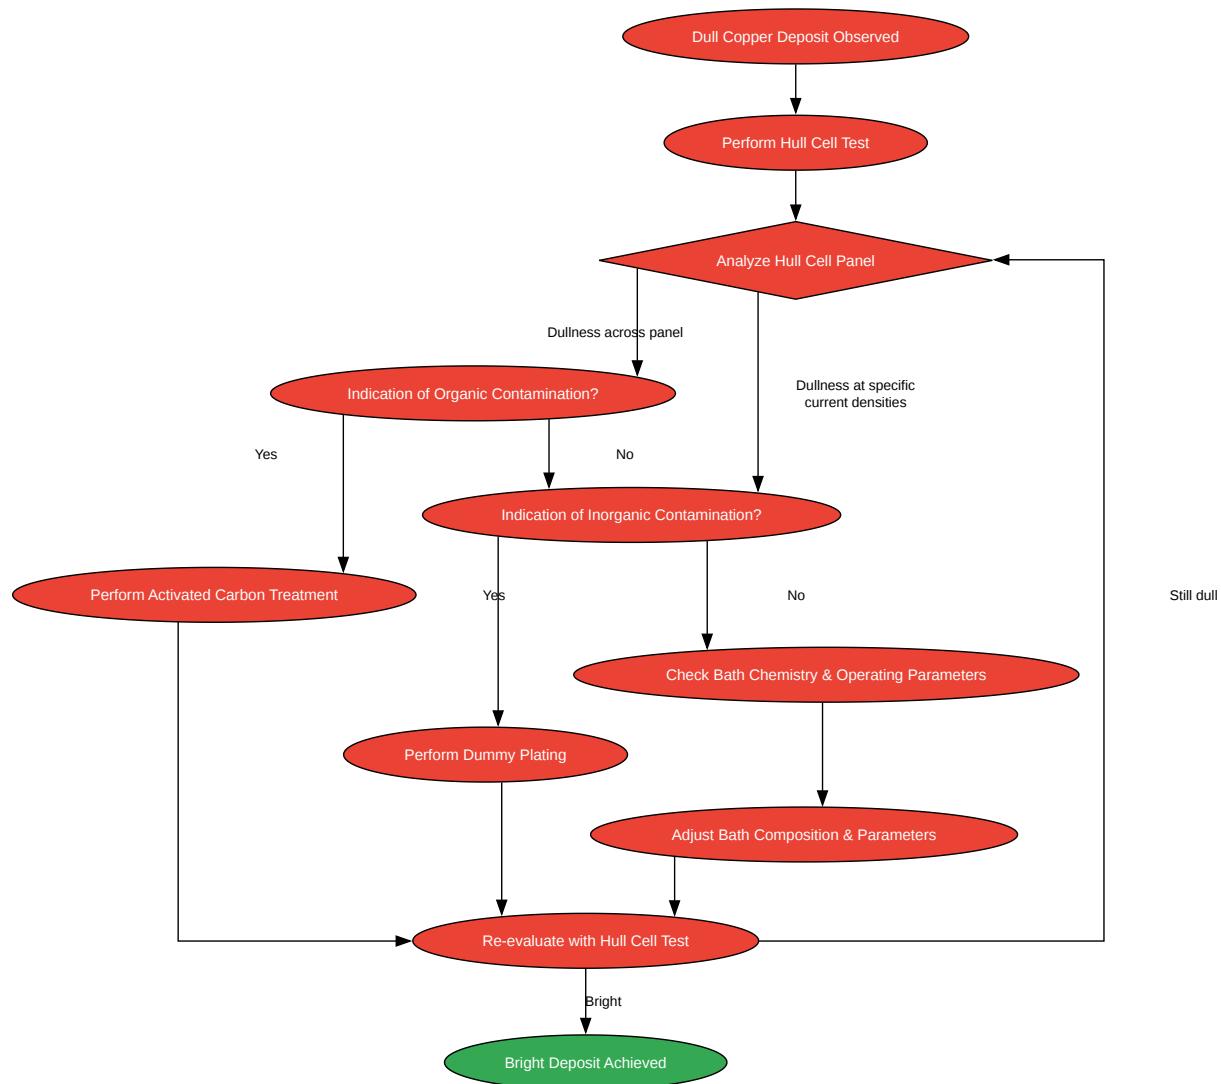
The following diagram illustrates a logical workflow for troubleshooting dull copper plating.

Caption: Troubleshooting workflow for dull copper plating.

Answer: Dull deposits can be attributed to three main categories: organic contamination, inorganic contamination, and incorrect bath parameters. A systematic approach to troubleshooting is recommended.
