troubleshooting peak tailing of propyl octanoate in GC analysis

Technical Support Center: GC Analysis of Propyl Octanoate

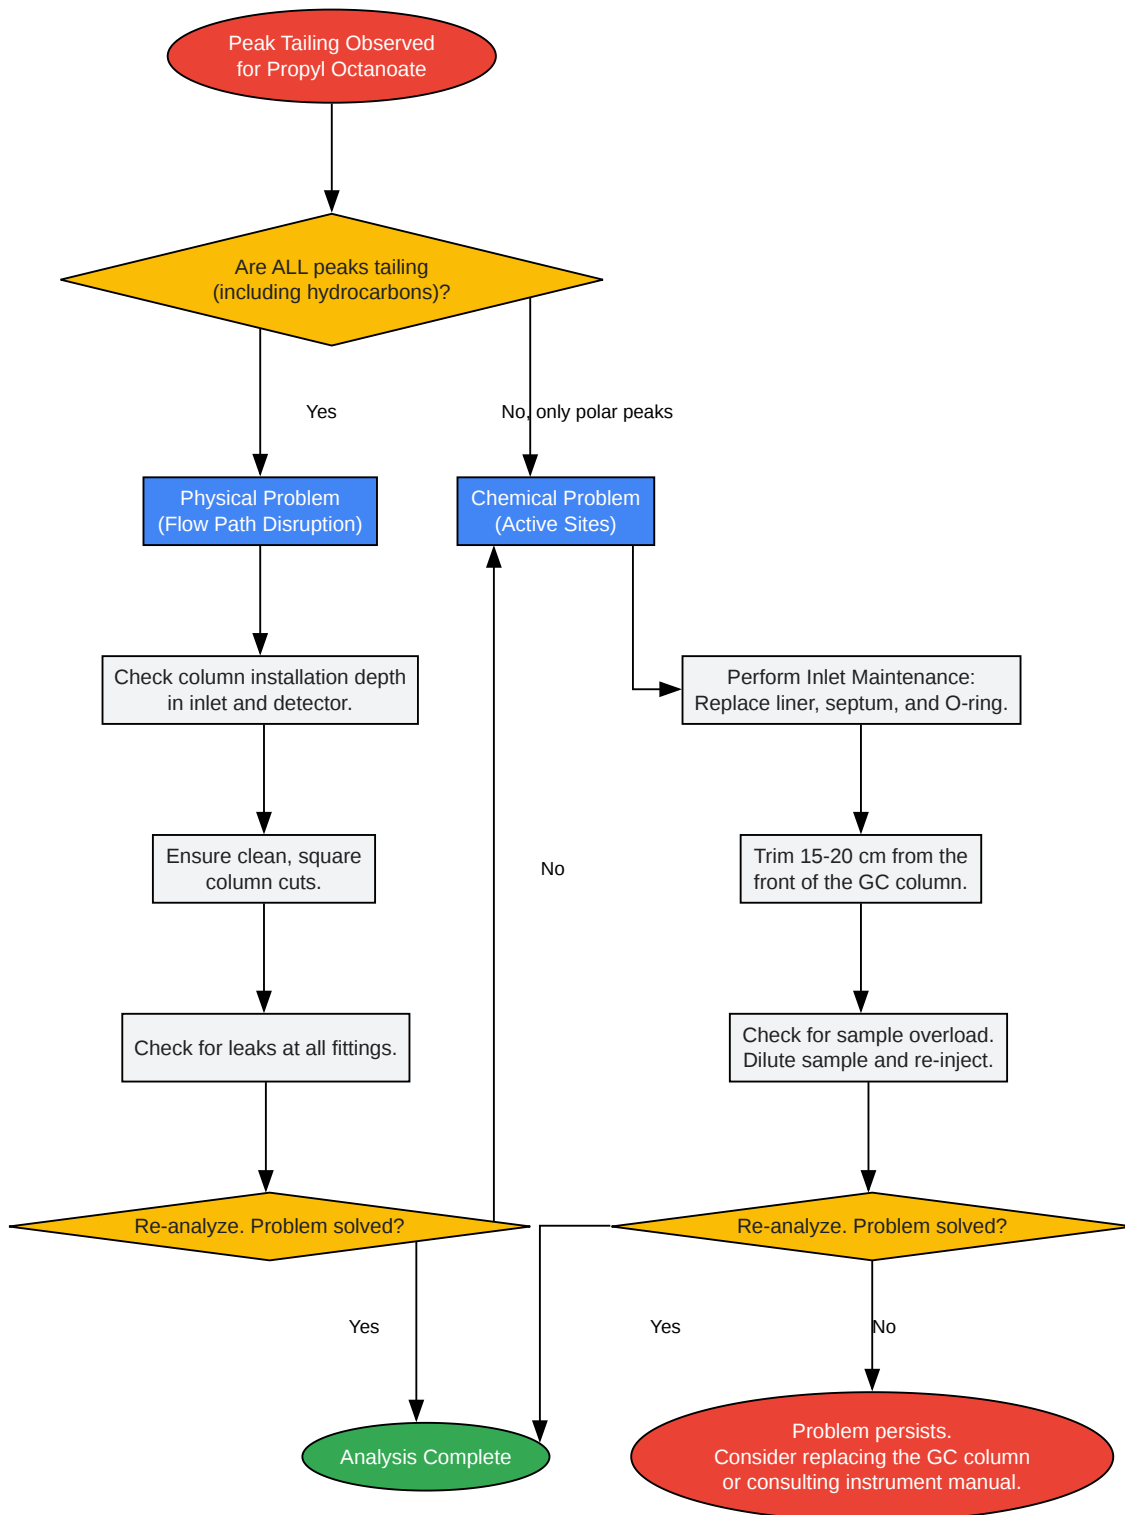
Troubleshooting Workflow for Peak Tailing

A systematic approach is the best way to identify the root cause. The following workflow can guide your troubleshooting process.

A flowchart for diagnosing the cause of GC peak tailing.
