Technical Support Center: Troubleshooting GC Analysis of PCB 48

Compound Name: 2,2',4,5'-Tetrachlorobiphenyl

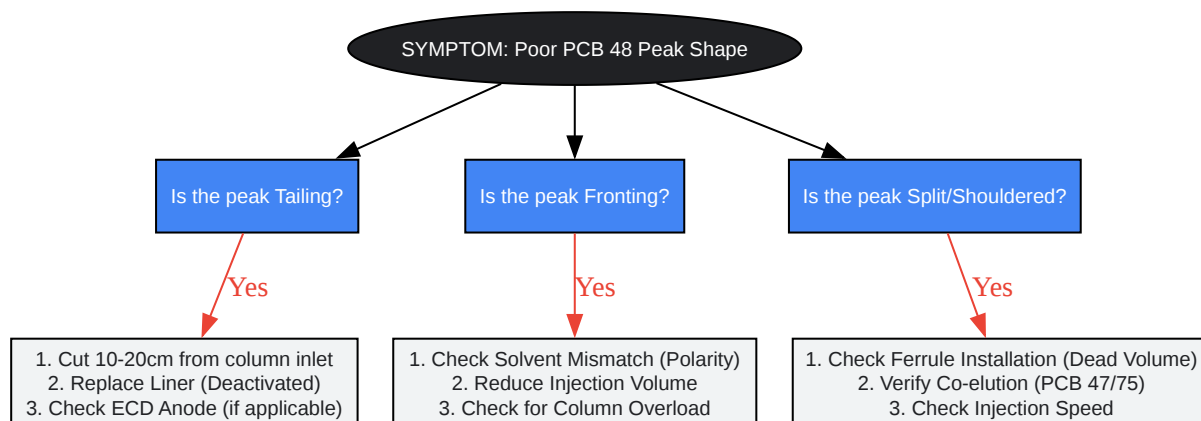
Before disassembling your instrument, use this logic tree to isolate the root cause. Most peak shape issues stem from the Inlet or Flow Path, not the detector.

Figure 1: Diagnostic logic tree for isolating peak shape anomalies in PCB analysis.
