Technical Support Center: Troubleshooting GC Analysis of Rose Oxide

This technical support guide provides troubleshooting advice for common issues encountered during the Gas Chromatography (GC) analysis of rose oxide, with a specific focus on addressing peak tailing.

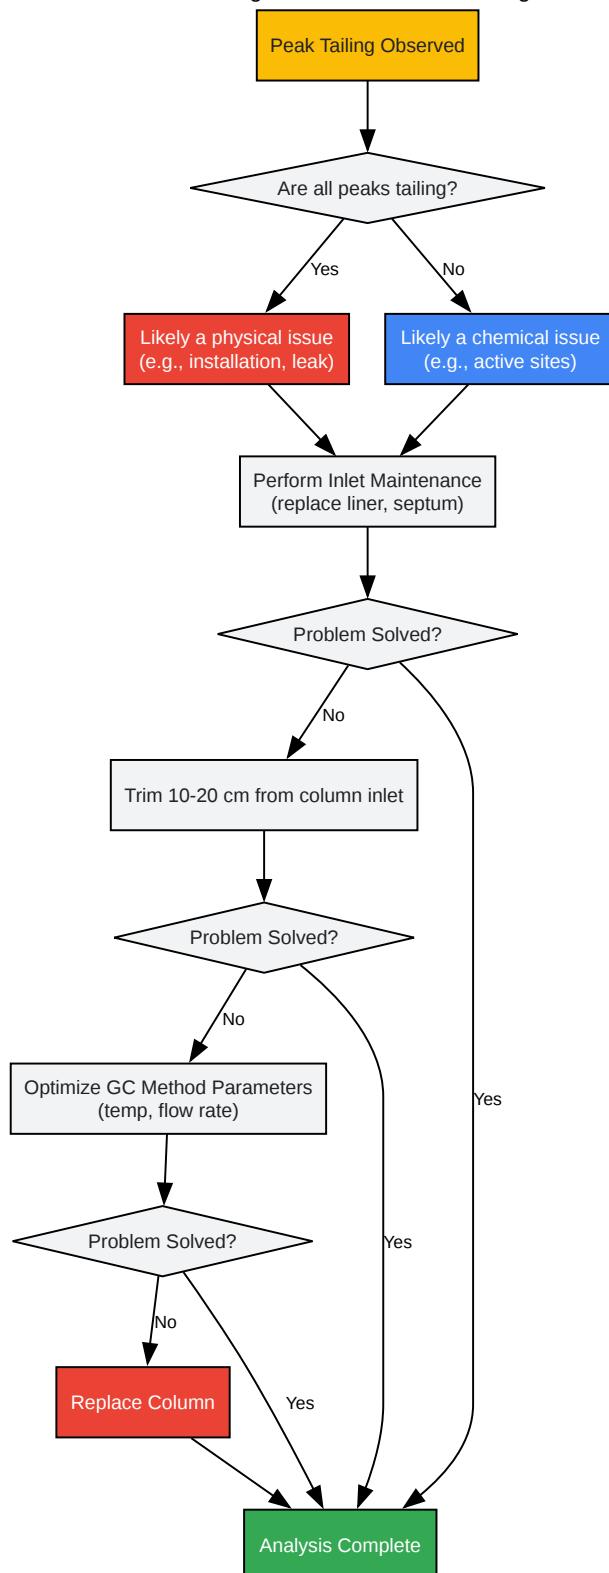
Troubleshooting Workflow for Peak Tailing

Below are diagrams to help visualize the troubleshooting workflow and the underlying causes of peak tailing.

- Indiscriminate Tailing (All Peaks Tail): This usually points to a physical problem in the flow path, such as improper column installation or a leak.[3]
- Selective Tailing (Only Rose Oxide or Polar Compounds Tail): This is more indicative of a chemical interaction issue, such as active sites in the liner or column contamination.[3]
