Technical Support Center: Troubleshooting Peak Tailing in GC Analysis of Tetrachloroethylene

Author: BenchChem Technical Support Team. **Date:** December 2025

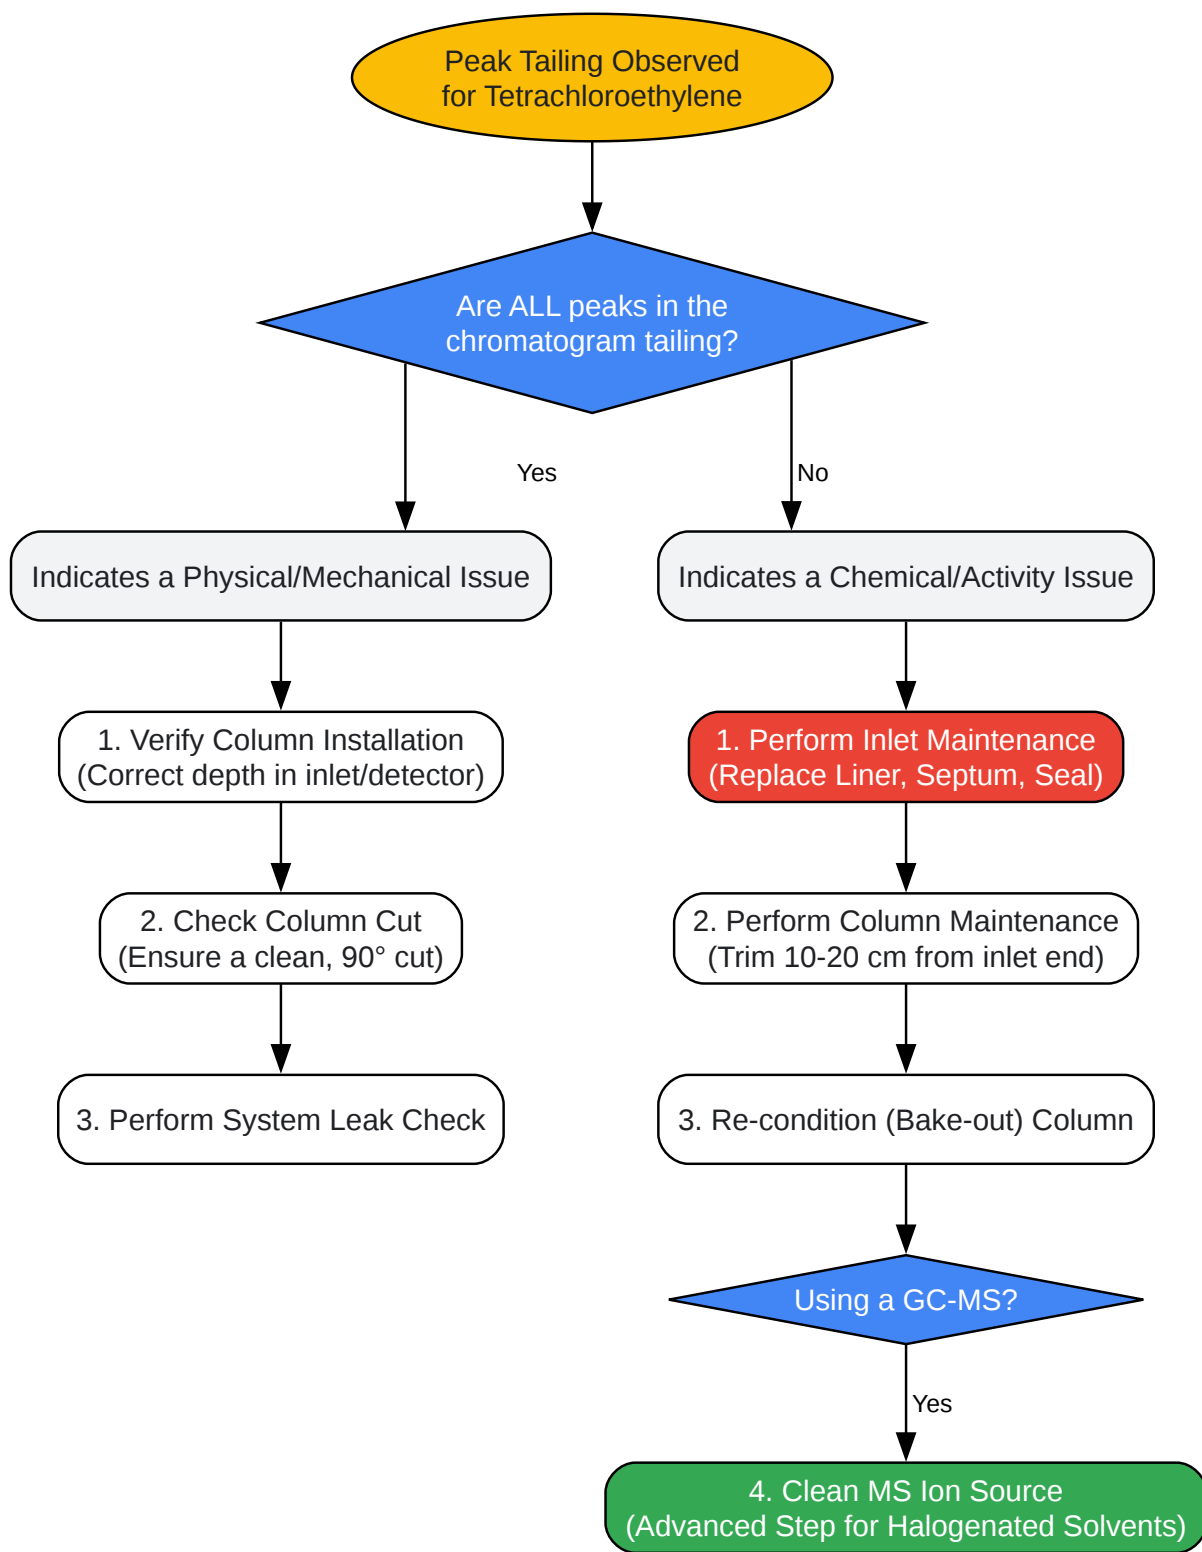
The following diagram illustrates the recommended decision-making process when you observe peak tailing.

Caption: A workflow for diagnosing the cause of peak tailing in GC.

This guide provides a logical workflow to diagnose and resolve the root cause of peak tailing.

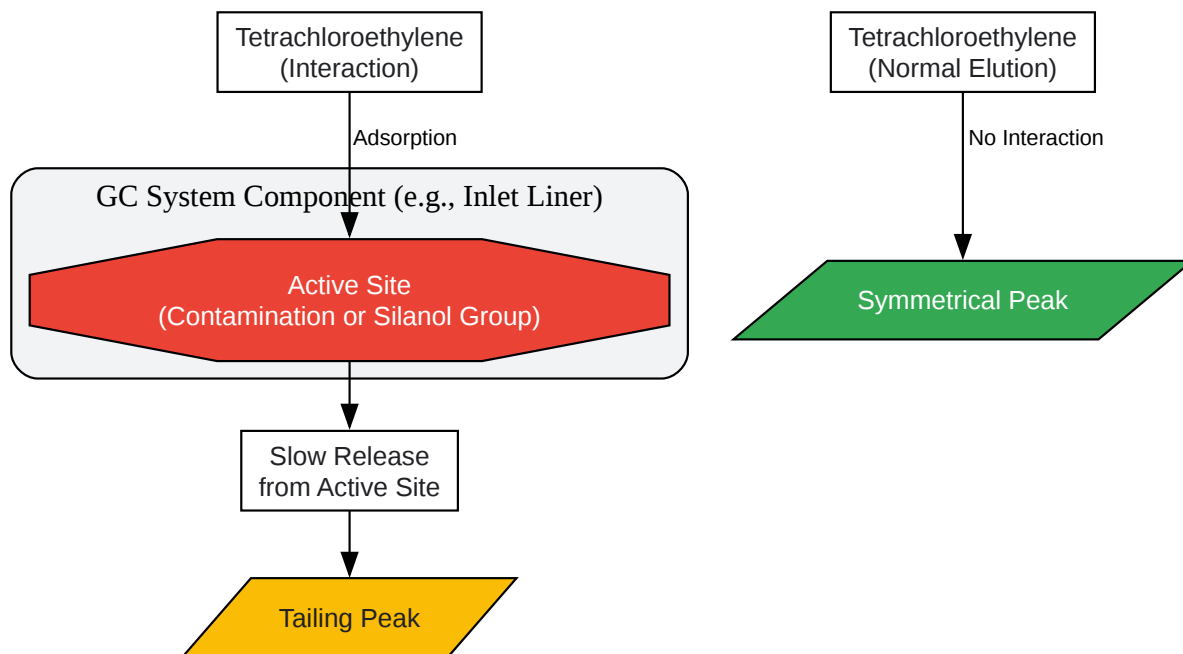
Caption: The mechanism of peak tailing due to active sites in the GC system.
