Troubleshooting peak tailing in GC analysis of 2,3-Dimethyl-3-octene

Technical Support Center: GC Analysis of 2,3-Dimethyl-3-octene

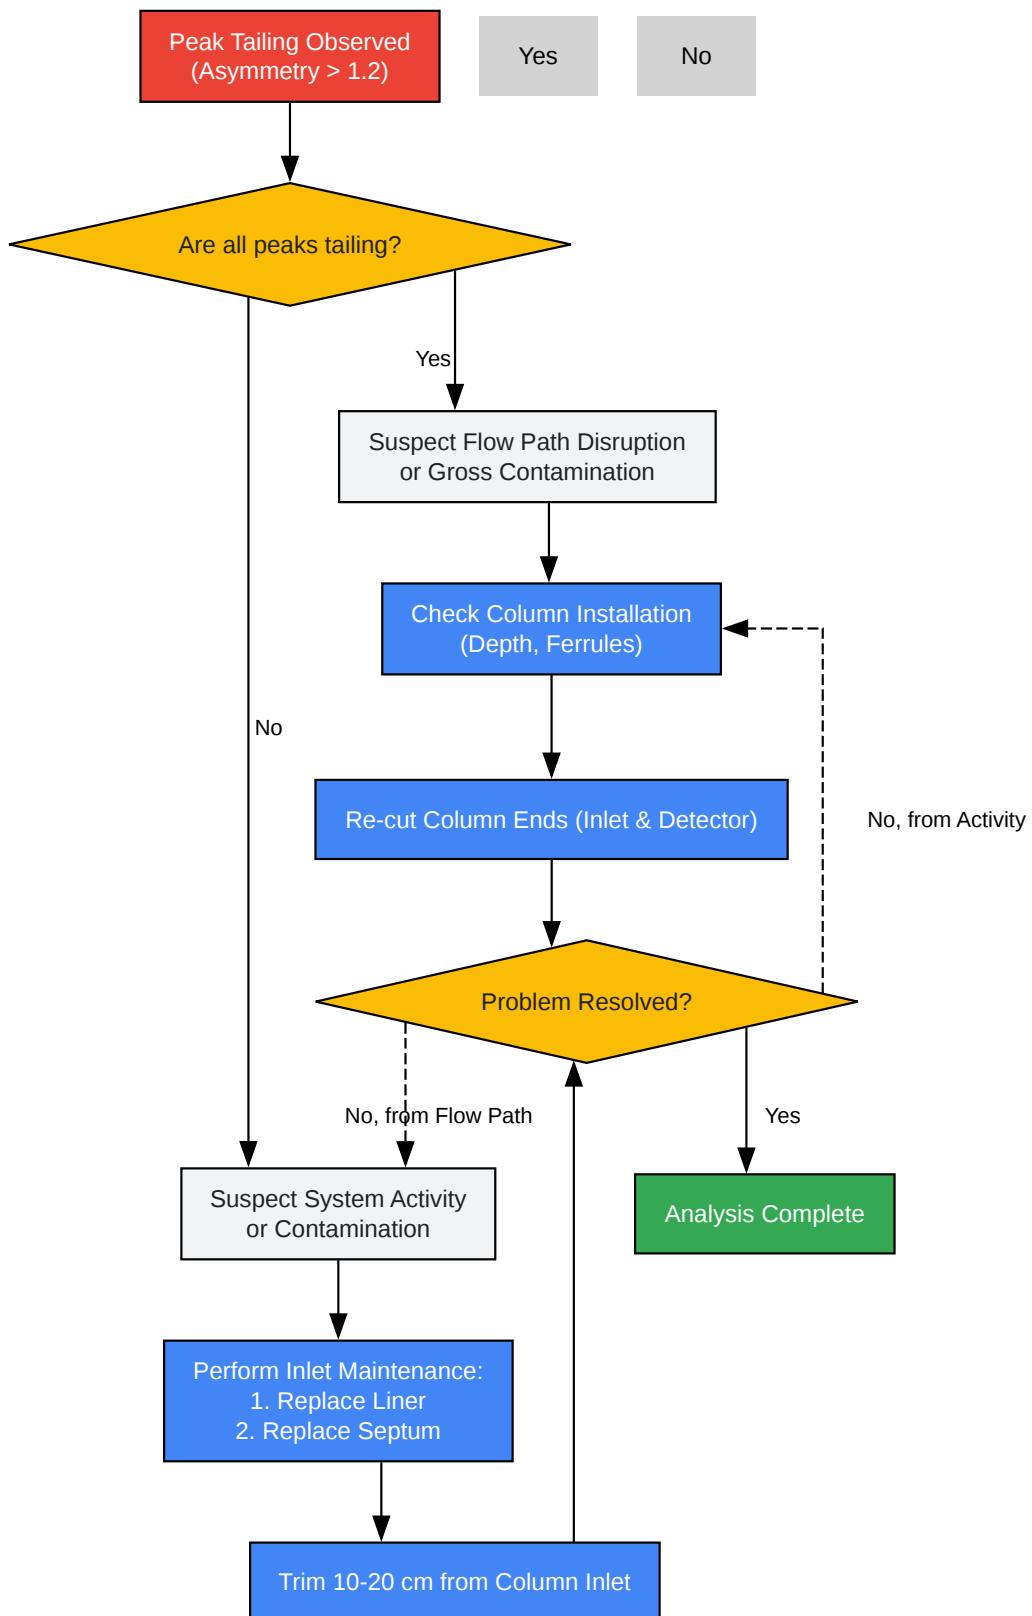
The following diagram outlines a logical workflow for diagnosing and resolving peak tailing issues.

Caption: A logical workflow for troubleshooting peak tailing in GC analysis.
