how to minimize phase-stepping errors in Talbot interferometry

Technical Support Center: Talbot Interferometry

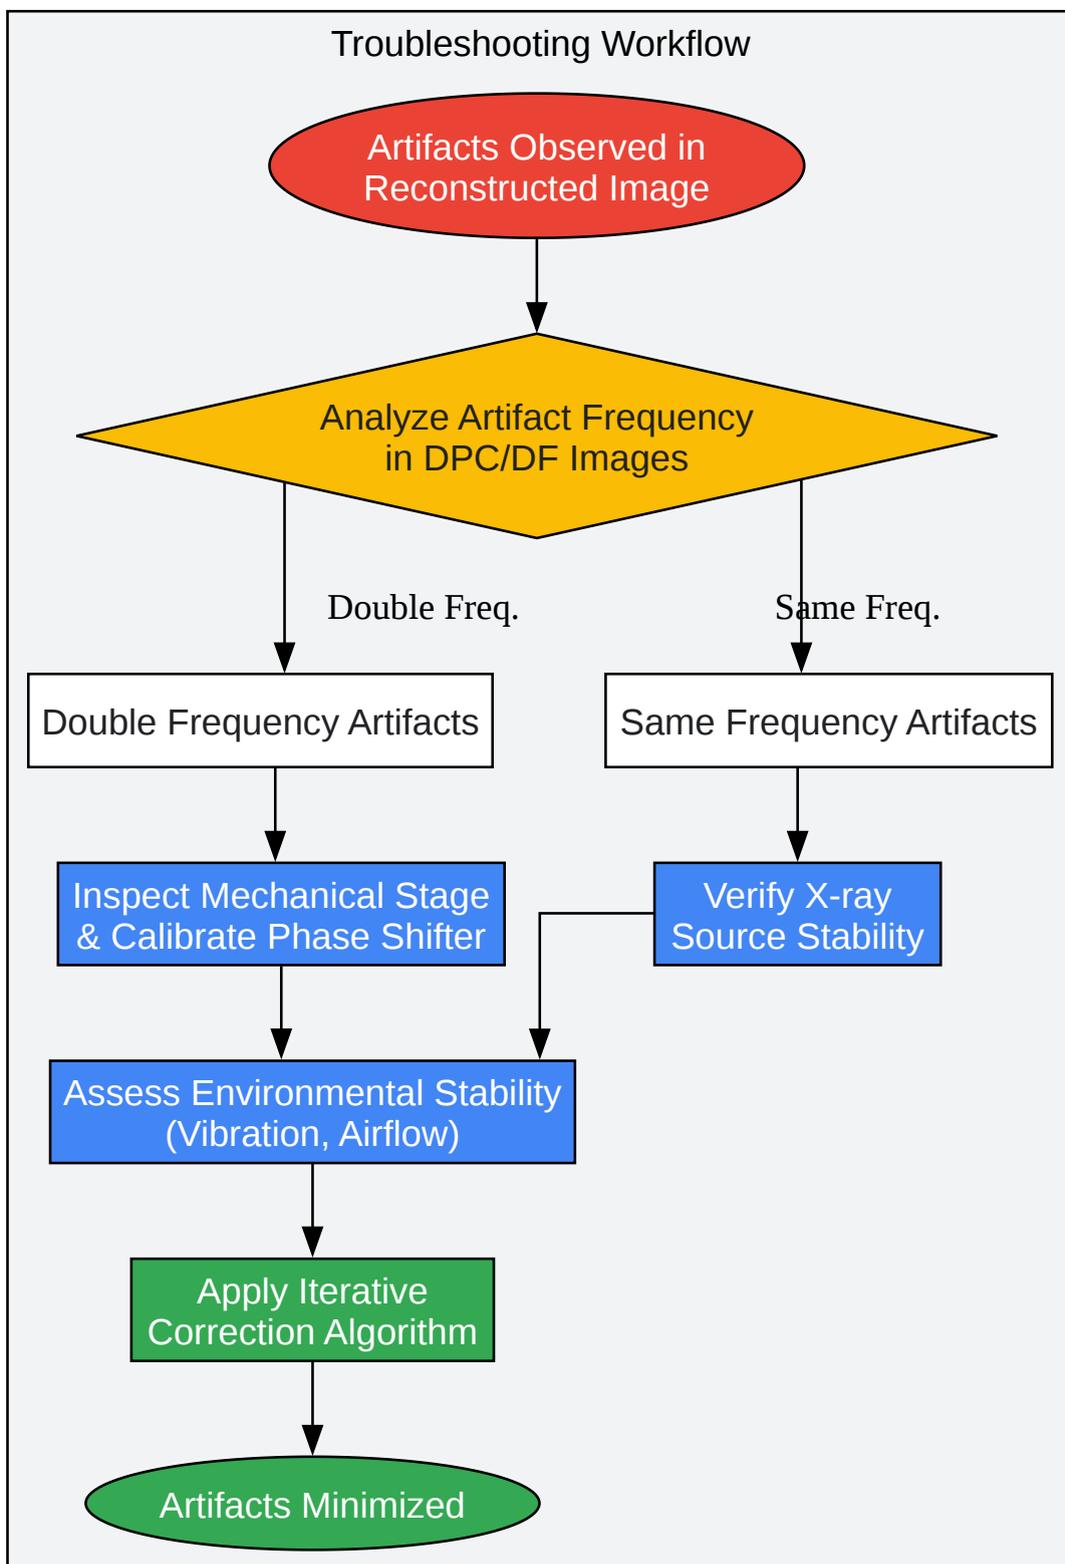
Caption: A general workflow for troubleshooting artifacts in **Talbot** interferometry.

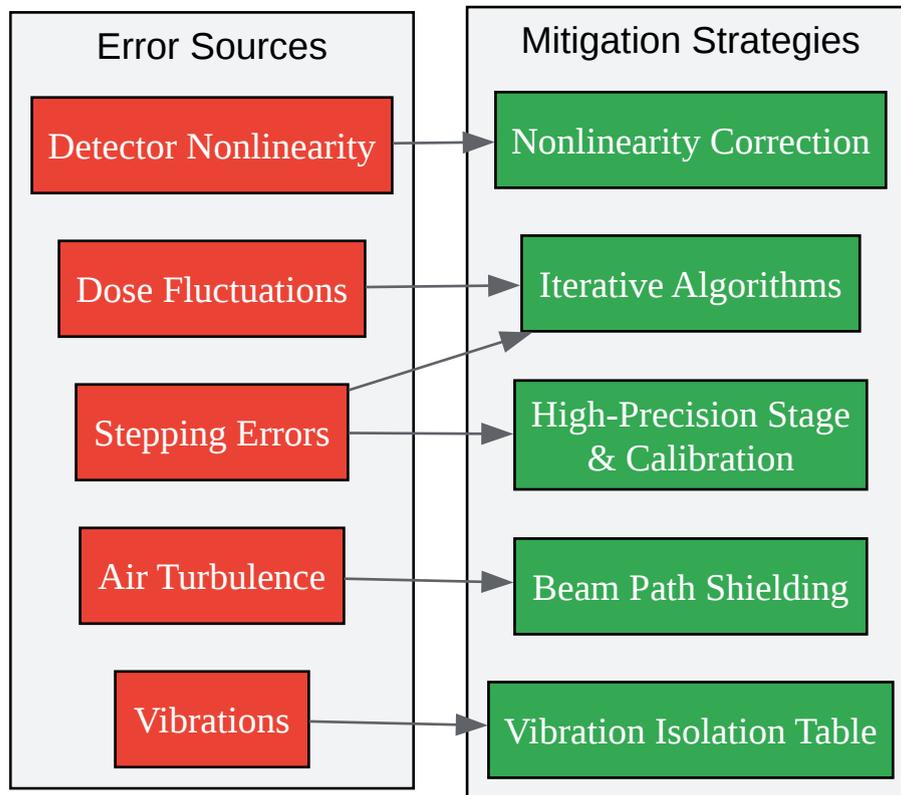
Caption: Logical relationships between error sources and their mitigation strategies.

Error Source	Type	Primary Mitigation Strategy	Secondary Mitigation Strategy
Stepping Error	Mechanical	Use high-precision motorized stage	Iterative reconstruction algorithms[2][4]
Vibration	Environmental	Vibration isolation table[8][9]	Shielding, post-processing filters[10]
Air Turbulence	Environmental	Enclose the beam path[3]	High-speed data acquisition[5]
Thermal Drift	Environmental	Stable temperature environment	Shorter acquisition times
Dose Fluctuation	Source	Use a highly stable X-ray source	Iterative reconstruction algorithms[2][4]
Detector Nonlinearity	Detector	Detector characterization & correction[12]	Joint least-squares algorithms[11]
Phase Step Miscalibration	System	Precise phase shifter calibration[6]	Self-calibrating algorithms[6]
