# Technical Support Center: GC-MS Analysis of Branched Alkanes

This guide provides troubleshooting assistance for common issues encountered during the Gas Chromatography-Mass Spectrometry (GC-MS) analysis of branched alkanes, with a specific focus on resolving peak tailing.

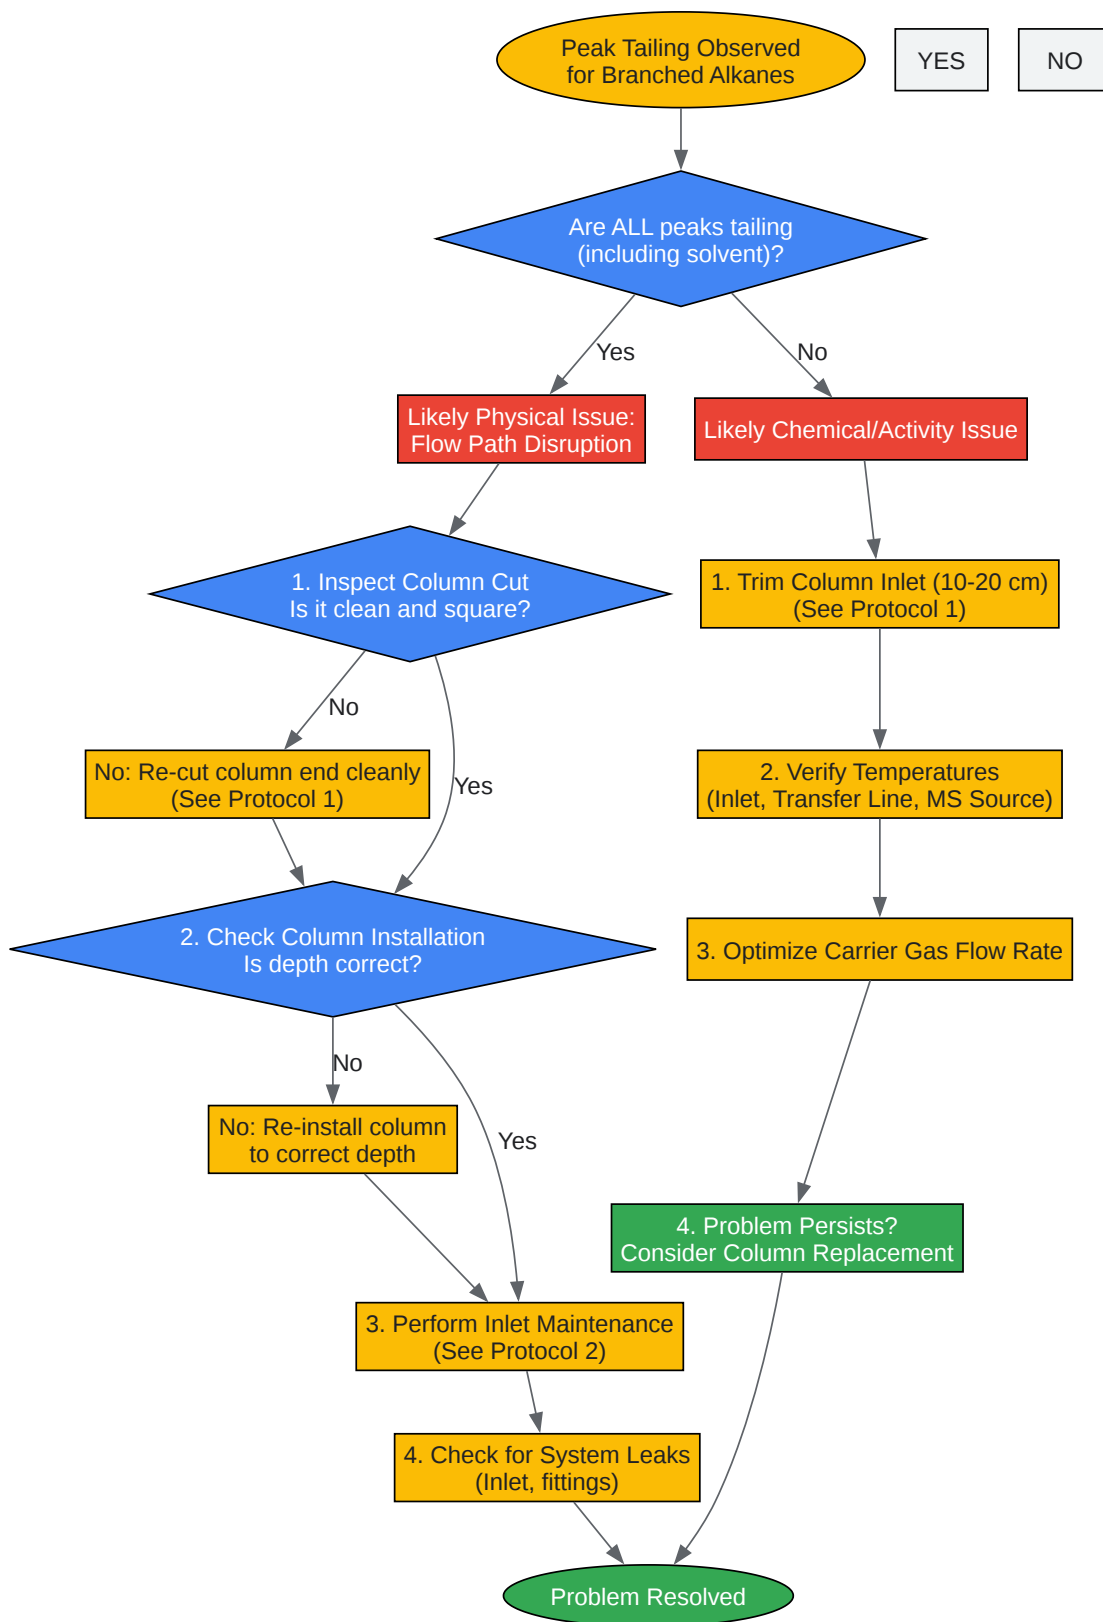
The following diagram outlines a logical workflow for diagnosing and resolving peak tailing issues for branched alkanes in GC-MS.

Caption: Troubleshooting workflow for peak tailing in GC-MS.
