Technical Support Center: GC/MS Analysis of Dibenzo[a,c]anthracene-13C6

This technical support guide provides troubleshooting advice for researchers, scientists, and drug development professionals encountering peak tailing with **Dibenzo[a,c]anthracene-13C6** in Gas Chromatography/Mass Spectrometry (GC/MS) analysis.

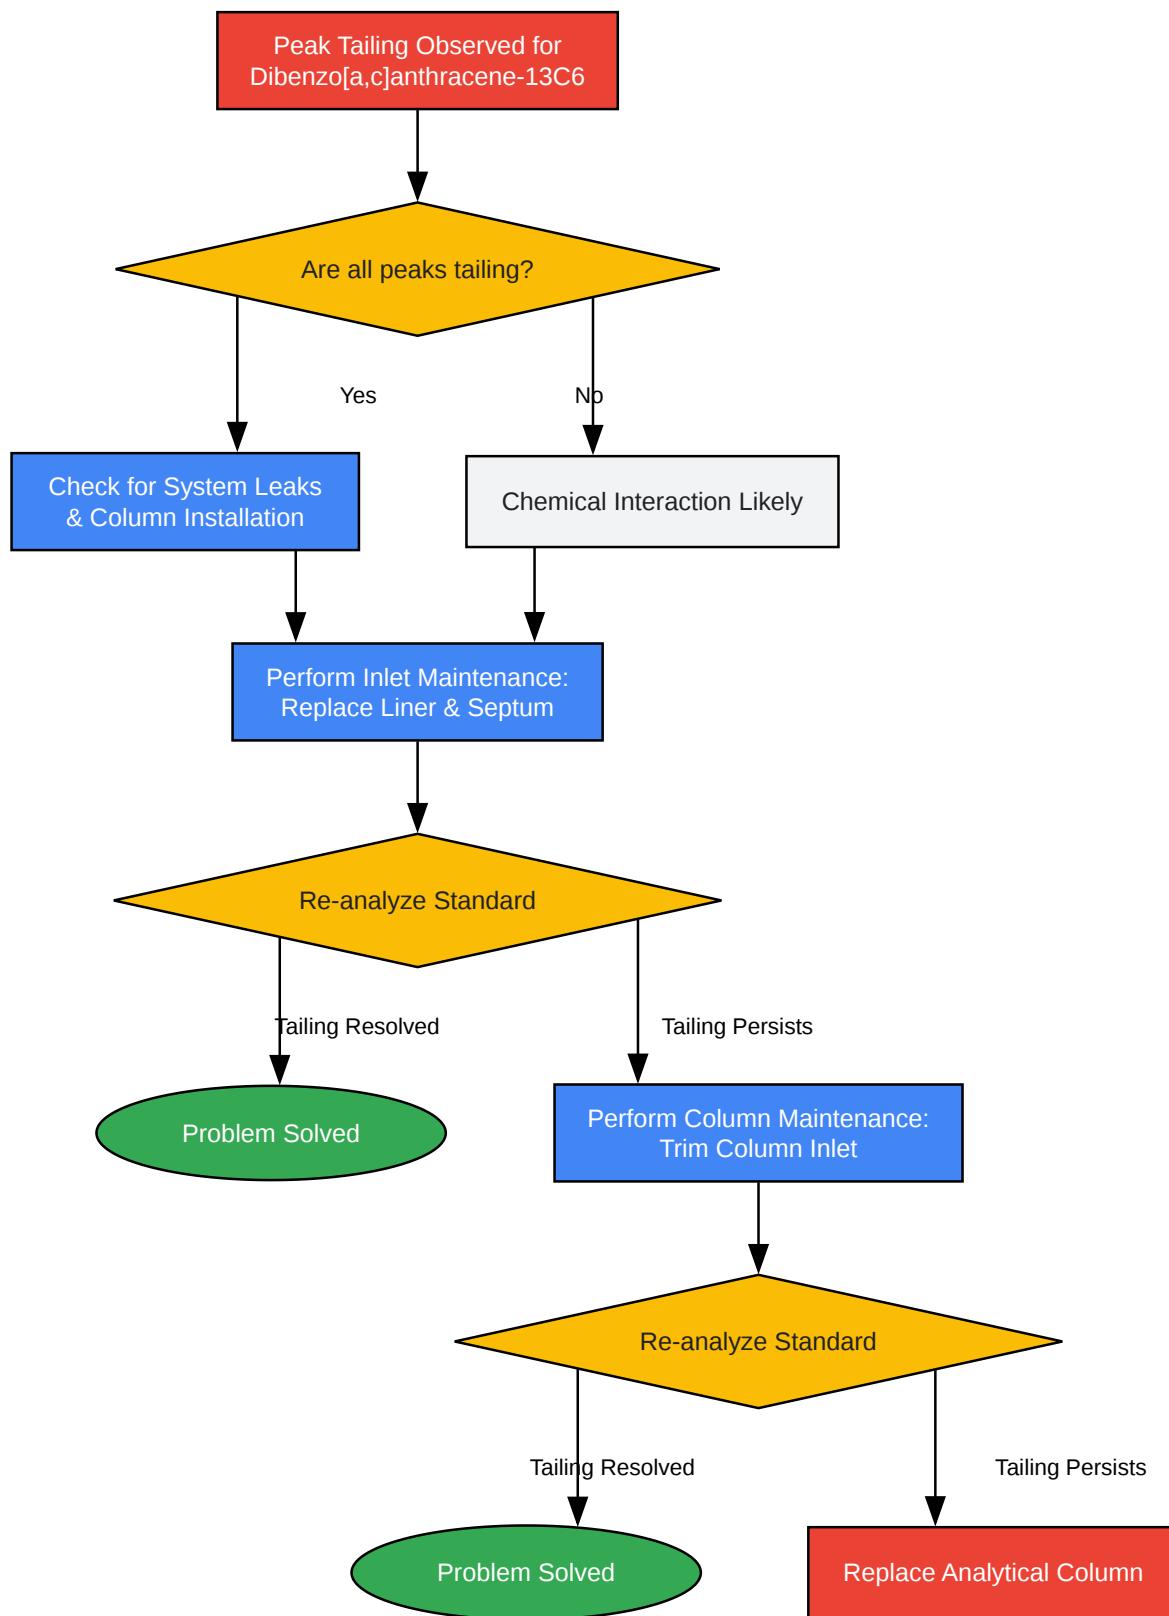
Caption: Troubleshooting workflow for peak tailing.

- Cool the injector and oven.
- Replace the inlet septum and liner with new, deactivated components. A liner with deactivated glass wool is recommended for analyzing complex matrices.^[9]
- Re-install the column, ensuring a clean, square cut at the inlet and the correct installation depth.
- Heat the system and allow it to stabilize.

- Compare the peak shape to the initial assessment. If peak tailing is resolved, the issue was with the inlet components.
- Column Maintenance (if tailing persists):
 - Cool the system down.
 - Trim approximately 15-20 cm from the front of the analytical column.[4]
 - Re-install the column in the inlet.
 - Heat and stabilize the system.
- Post-Column Maintenance Analysis:
 - Inject the standard solution again.
 - If peak tailing is now resolved, the issue was contamination at the head of the column.
- Column Replacement (if tailing still persists):
 - If the above steps do not resolve the peak tailing, the column itself may be irreversibly damaged or unsuitable for the application. Replace it with a new column recommended for PAH analysis.[5]

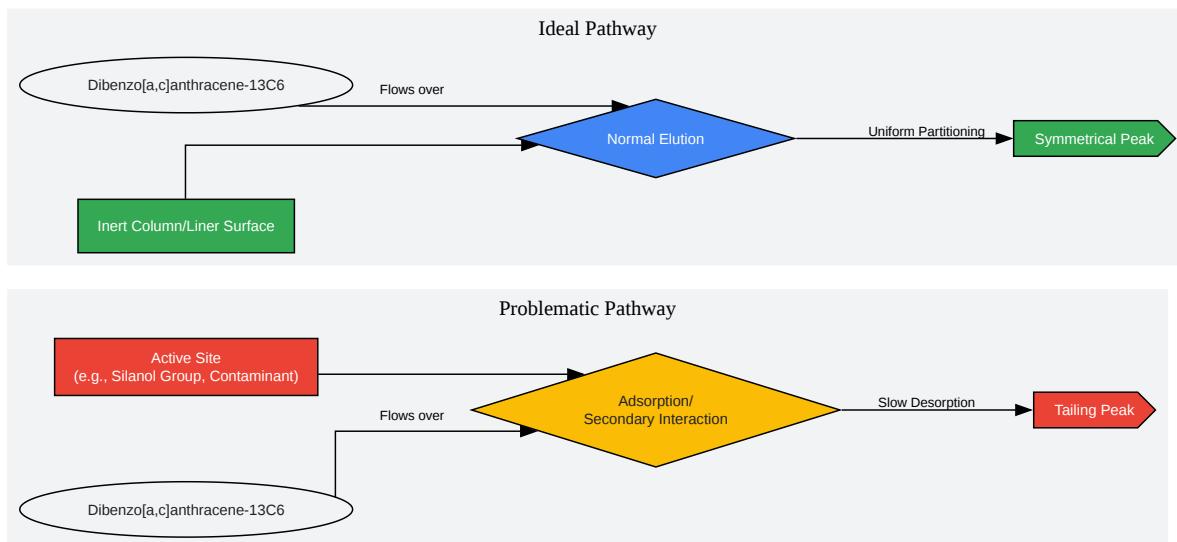
Caption: Analyte interaction with active sites leading to peak tailing.

Peak tailing for polycyclic aromatic hydrocarbons (PAHs) like **Dibenzo[a,c]anthracene-13C6** is often a result of active sites within the GC/MS system. These active sites can cause undesirable interactions with the analyte, leading to a distorted peak shape. Common sources of these active sites include:

This scenario strongly suggests a chemical interaction between your analyte and active sites within the system, rather than a physical problem like a leak or flow path obstruction.[8] Dibenzo[a,c]anthracene, although non-polar, can still interact with active silanol groups or contaminants in the liner or at the head of the column. The other non-polar compounds might be less susceptible to these interactions.
