# How to correct uneven staining with Azure A eosinate.

## Technical Support Center: Azure A Eosinate Staining

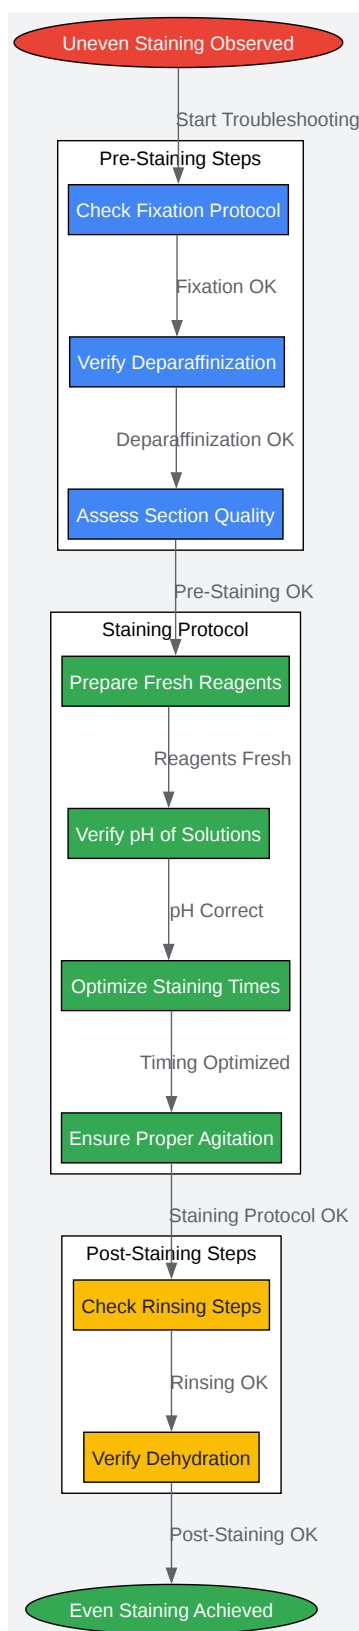
The following diagram illustrates a logical workflow for troubleshooting uneven **Azure A eosinate** staining.

Caption: Troubleshooting workflow for uneven **Azure A eosinate** staining.
