Resolving peak tailing issues in gas chromatography analysis of Chloroxuron

Technical Support Center: Gas Chromatography Analysis of Chloroxuron

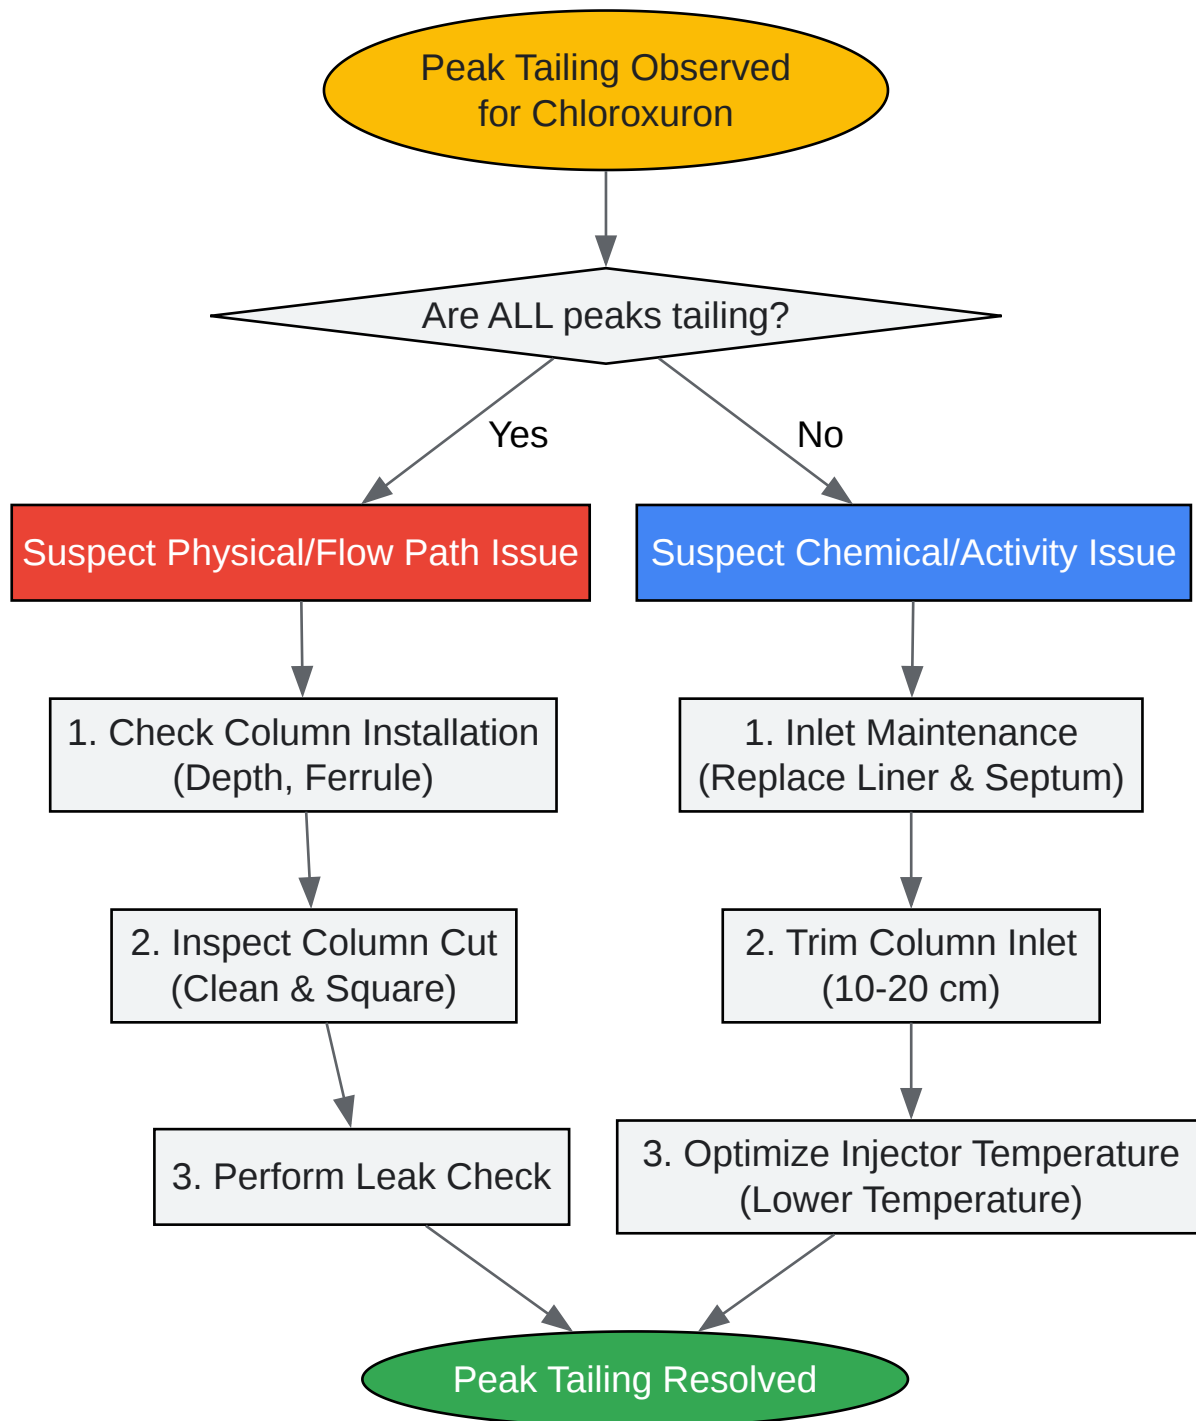
Troubleshooting Workflow for Chloroxuron Peak Tailing

If the initial checks do not resolve the issue, follow this systematic workflow. A visual representation of this workflow is provided in the diagram below.

Caption: A systematic workflow for troubleshooting peak tailing in **Chloroxuron** GC analysis.

- Perform Inlet Maintenance:
 - Action: The injector liner is a common source of active sites and contamination.[\[9\]](#) Replace the inlet liner with a new, deactivated liner. Also, replace the septum, as septum particles can be a source of contamination.[\[9\]](#)
 - Tip: Using a liner with glass wool can help trap non-volatile residues, but the wool itself can become active over time.
- Trim the Column Inlet:

- Action: If inlet maintenance doesn't solve the problem, the front section of the column may be contaminated. Trim 10-20 cm from the inlet of the column.[4] This removes the most contaminated part of the column.
- Optimize Injector Temperature:
 - Action: **Chloroxuron**'s potential thermal lability means a high injector temperature can cause degradation, mimicking peak tailing.[6] Try reducing the injector temperature in 10-20 °C increments to find the lowest temperature that allows for efficient volatilization without degradation.
 - Tip: For highly sensitive compounds, consider using a cool on-column or programmed temperature vaporization (PTV) inlet if available.[5]

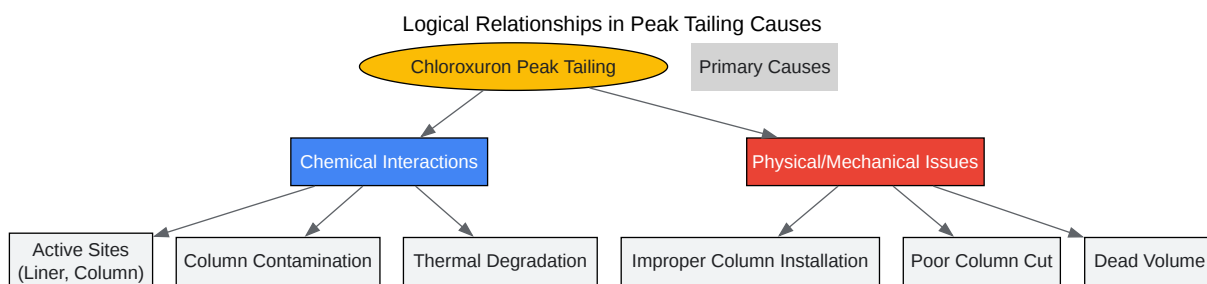
Caption: Key causes of peak tailing categorized into chemical and physical/mechanical issues.

- Improper GC System Setup: Physical issues like a poorly cut column, incorrect column installation depth in the inlet or detector, or the presence of dead volumes can disrupt the carrier gas flow path, leading to tailing for all compounds, including **Chloroxuron**. [2][3]

- Thermal Degradation: Phenylurea herbicides can be thermally labile, meaning they can degrade at high temperatures in the GC injector.[5] This degradation can result in broader, tailing peaks or the appearance of degradation product peaks that can be mistaken for tailing.[6]

- If all peaks in the chromatogram are tailing: The problem is more likely a physical issue related to the flow path, such as an improper column installation or a leak.[8]
