Troubleshooting peak tailing in GC analysis of 2-Ethylhexyl butyrate

Technical Support Center: Gas Chromatography Topic: Troubleshooting Peak Tailing in the GC Analysis of 2-Ethylhexyl Butyrate

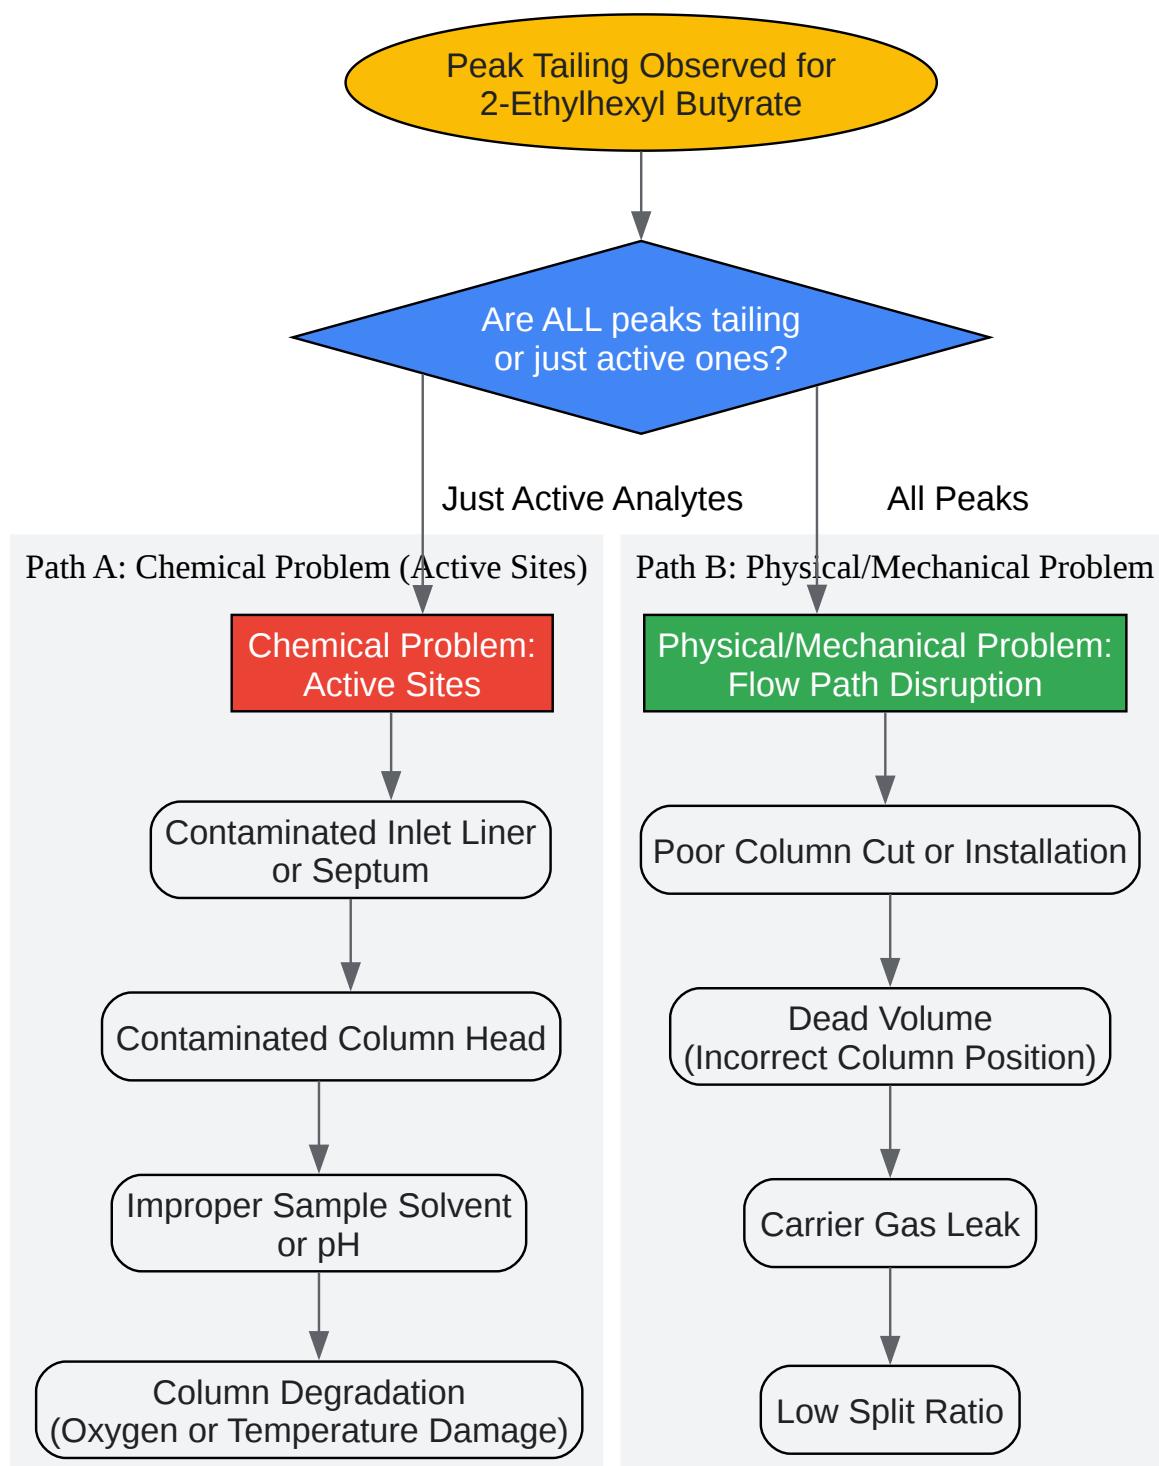
- Path A: Only Polar or Active Analytes are Tailing (e.g., **2-Ethylhexyl butyrate** tails, but hydrocarbons look fine). This points to a chemical problem, such as active sites in the system.[\[13\]](#)[\[15\]](#)
- Path B: All Peaks are Tailing. This suggests a physical or mechanical problem, such as a disruption in the carrier gas flow path.[\[13\]](#)[\[14\]](#)[\[15\]](#)

Below is a flowchart to visualize this diagnostic logic, followed by detailed protocols for each path.

Caption: Troubleshooting workflow for GC peak tailing.
