Technical Support Center: Troubleshooting Octachlorobiphenyl Analysis in GC

Topic: Optimization and Troubleshooting of Late-Eluting Polychlorinated Biphenyls (PCBs)
Applicable Methods: EPA 8082A, EPA 608, USP <467> (related), and internal drug development assays. Target Analytes: Octachlorobiphenyls (e.g., PCB 194, 196, 205) and Decachlorobiphenyl (PCB 209).

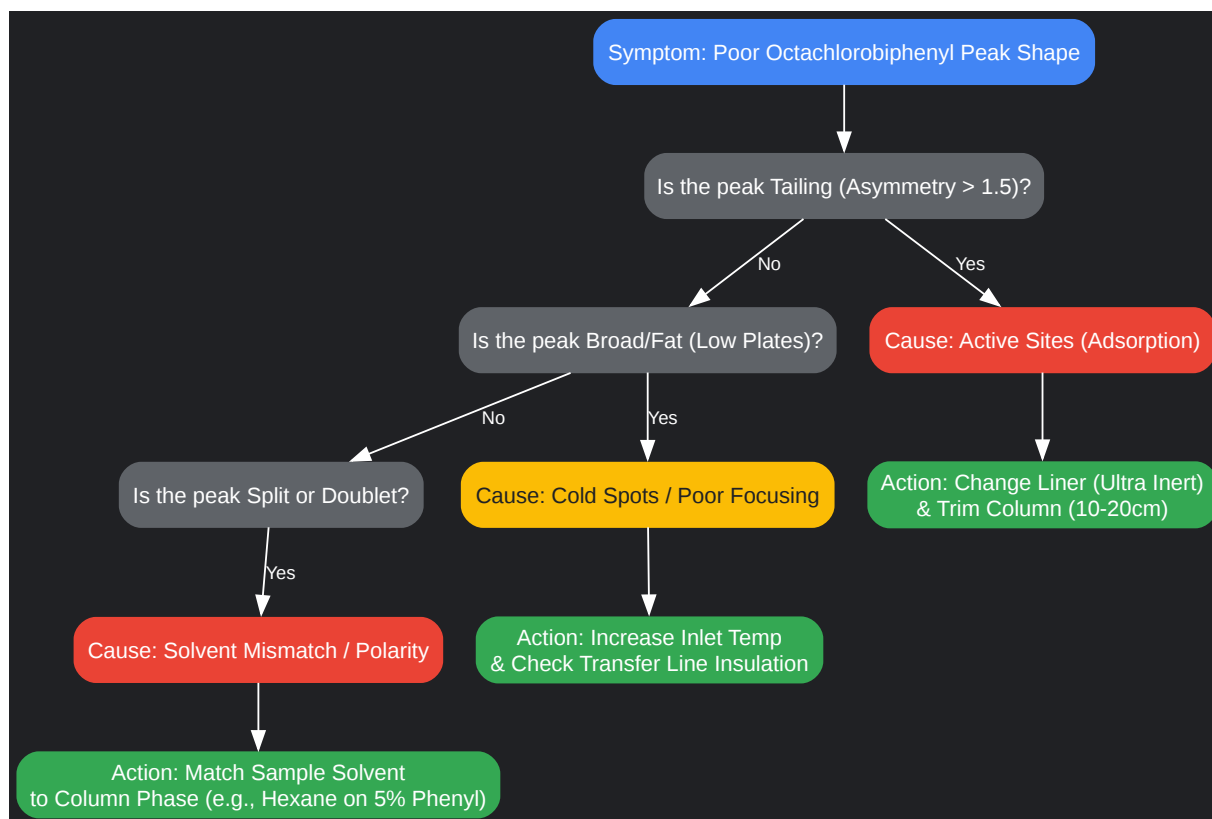
Use this decision matrix to identify the root cause based on peak topology.

Figure 1: Diagnostic logic flow for identifying root causes of peak shape distortion in late-eluting PCBs.

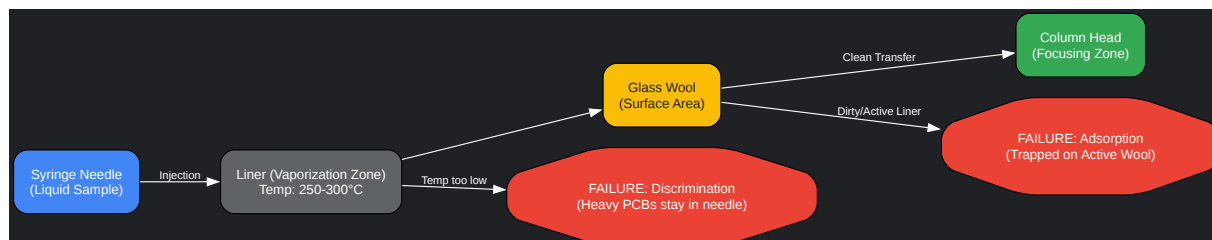
Understanding where the Octachlorobiphenyls get lost is key to fixing the problem.

Figure 2: Physical dynamics of injection showing where heavy PCBs (Octa/Deca) are lost due to discrimination or adsorption.[2][3]

The Mechanism: This is Inlet Discrimination.^{[1][2]} In a standard splitless injection, the syringe needle enters the hot inlet. If the boiling point of the analyte (Octa PCB > 400°C) is significantly higher than the inlet temperature, the analyte may condense on the needle tip or fail to vaporize fully before the split valve opens.

- Result: The heavy fraction remains in the liner/needle, while the solvent and light PCBs enter the column.
