# Technical Support Center: Troubleshooting Peak Tailing for Nitrapyrin in GC Analysis

This technical support center provides troubleshooting guides and frequently asked questions (FAQs) to help researchers, scientists, and drug development professionals resolve peak tailing issues encountered during the gas chromatography (GC) analysis of **Nitrapyrin**.

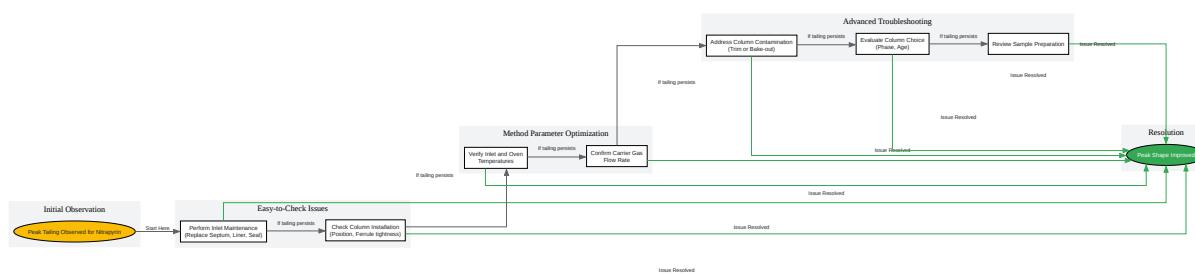
A systematic approach is crucial to efficiently identify the root cause of peak tailing. The following logical workflow can help pinpoint the issue.

Figure 1. A logical workflow for troubleshooting **Nitrapyrin** peak tailing.

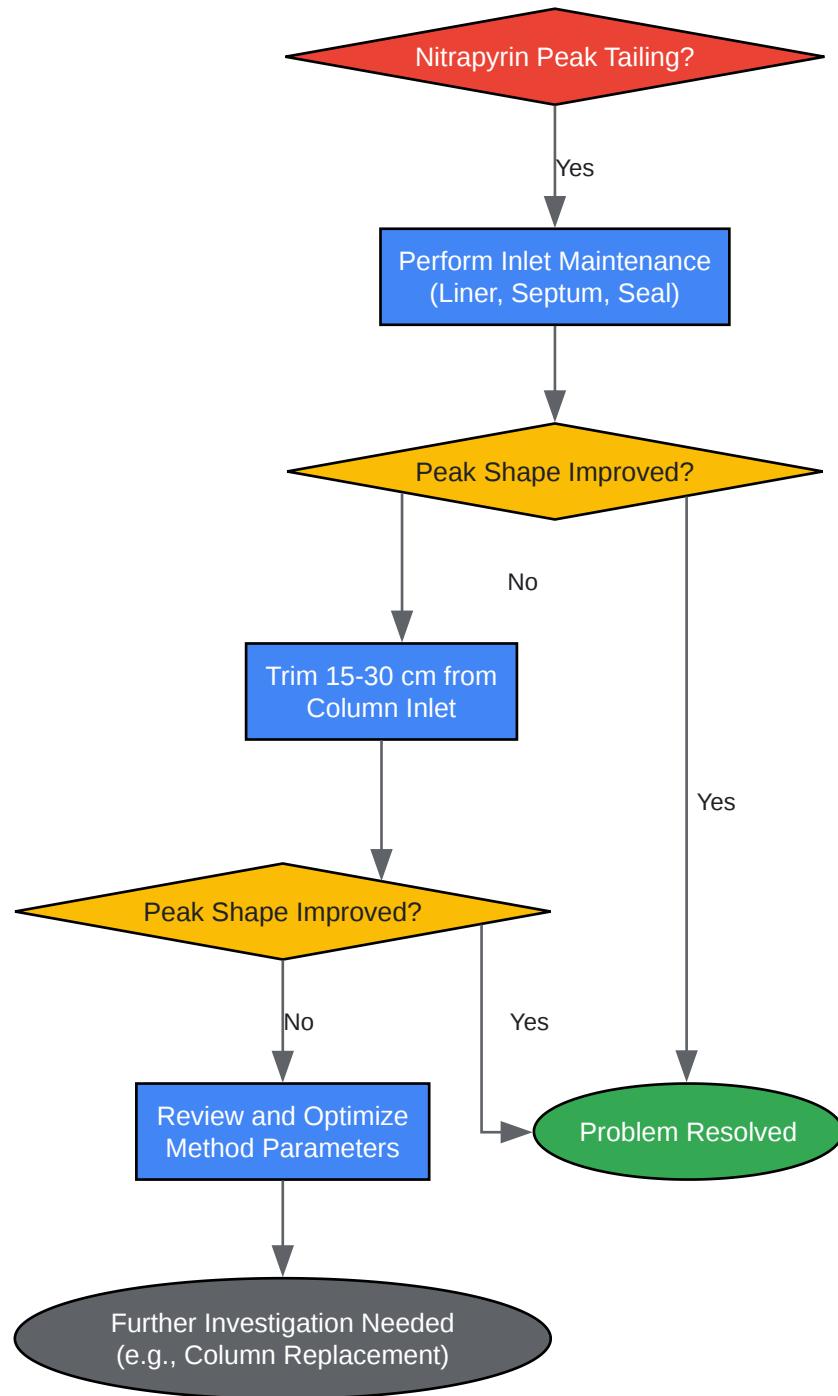
The following diagram illustrates the decision-making process when troubleshooting **Nitrapyrin** peak tailing, focusing on the initial steps.

Figure 2. Decision tree for initial troubleshooting steps.
