how to address channeling in an Amberlite SR1L NA bed

Technical Support Center: Amberlite SR1L NA

This guide provides troubleshooting advice and frequently asked questions for researchers, scientists, and drug development professionals experiencing channeling in an **Amberlite SR1L NA** ion exchange resin bed.

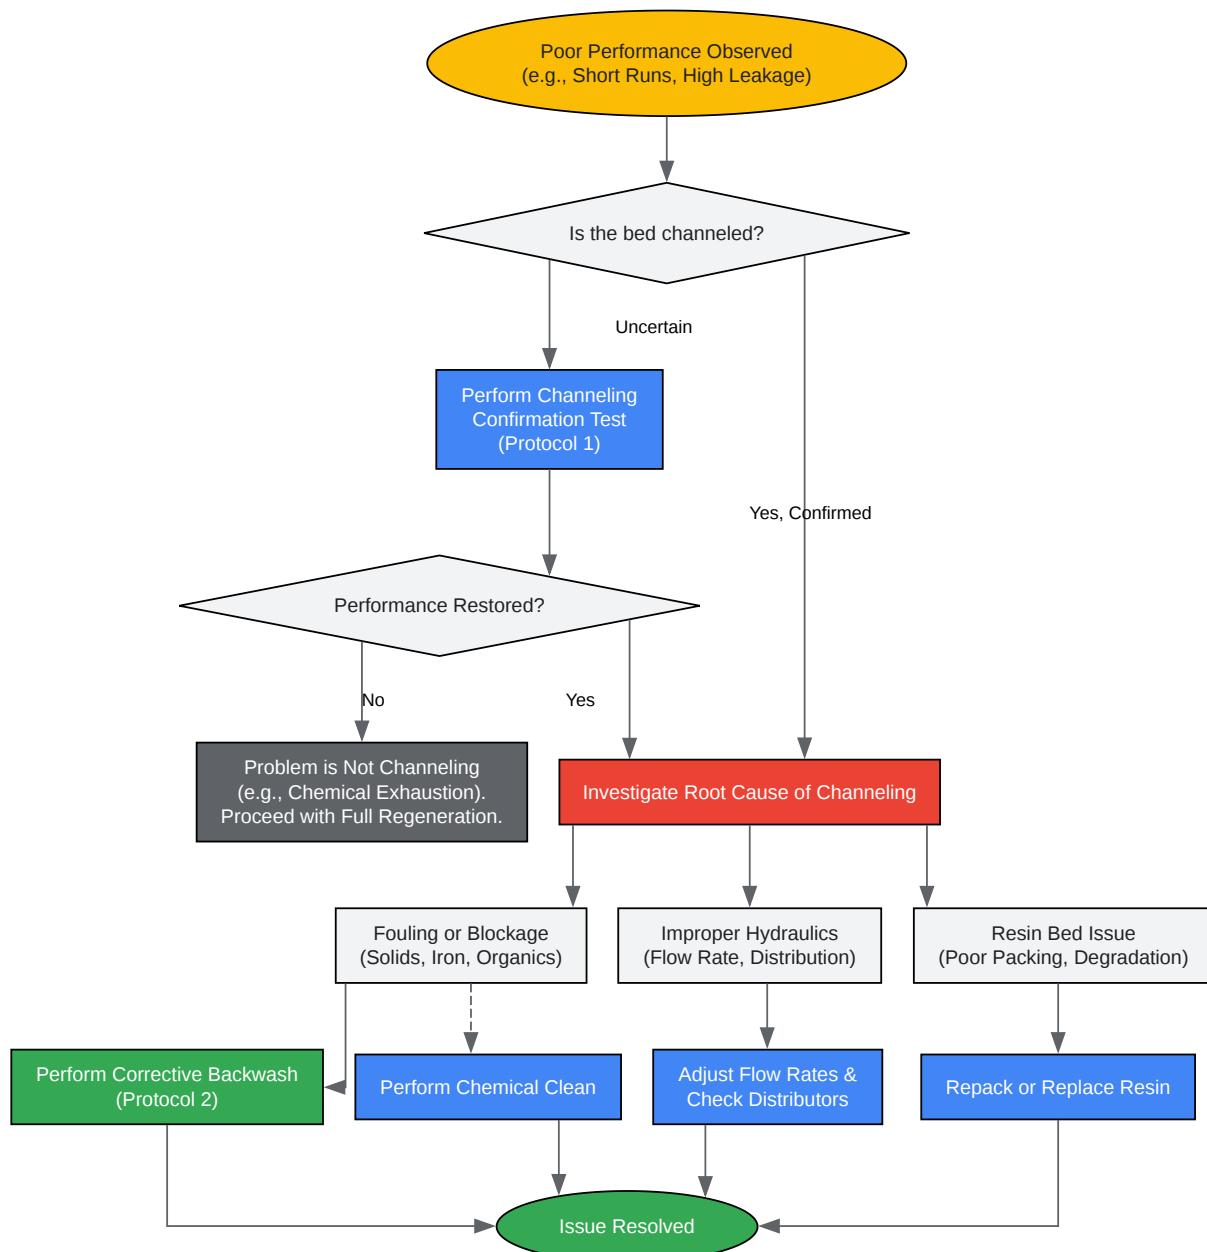
Caption: Troubleshooting workflow for identifying and resolving channeling in a resin bed.

A4: A straightforward diagnostic test can be performed to confirm channeling. This procedure involves bypassing the chemical regeneration steps to isolate the effect of a proper backwash. [\[2\]](#) If the bed performance is restored after this physical treatment, channeling was the likely cause of the issue.
