Technical Support Center: Troubleshooting Peak Tailing with n-Octylcyclohexane in GC

Author: BenchChem Technical Support Team. **Date:** December 2025

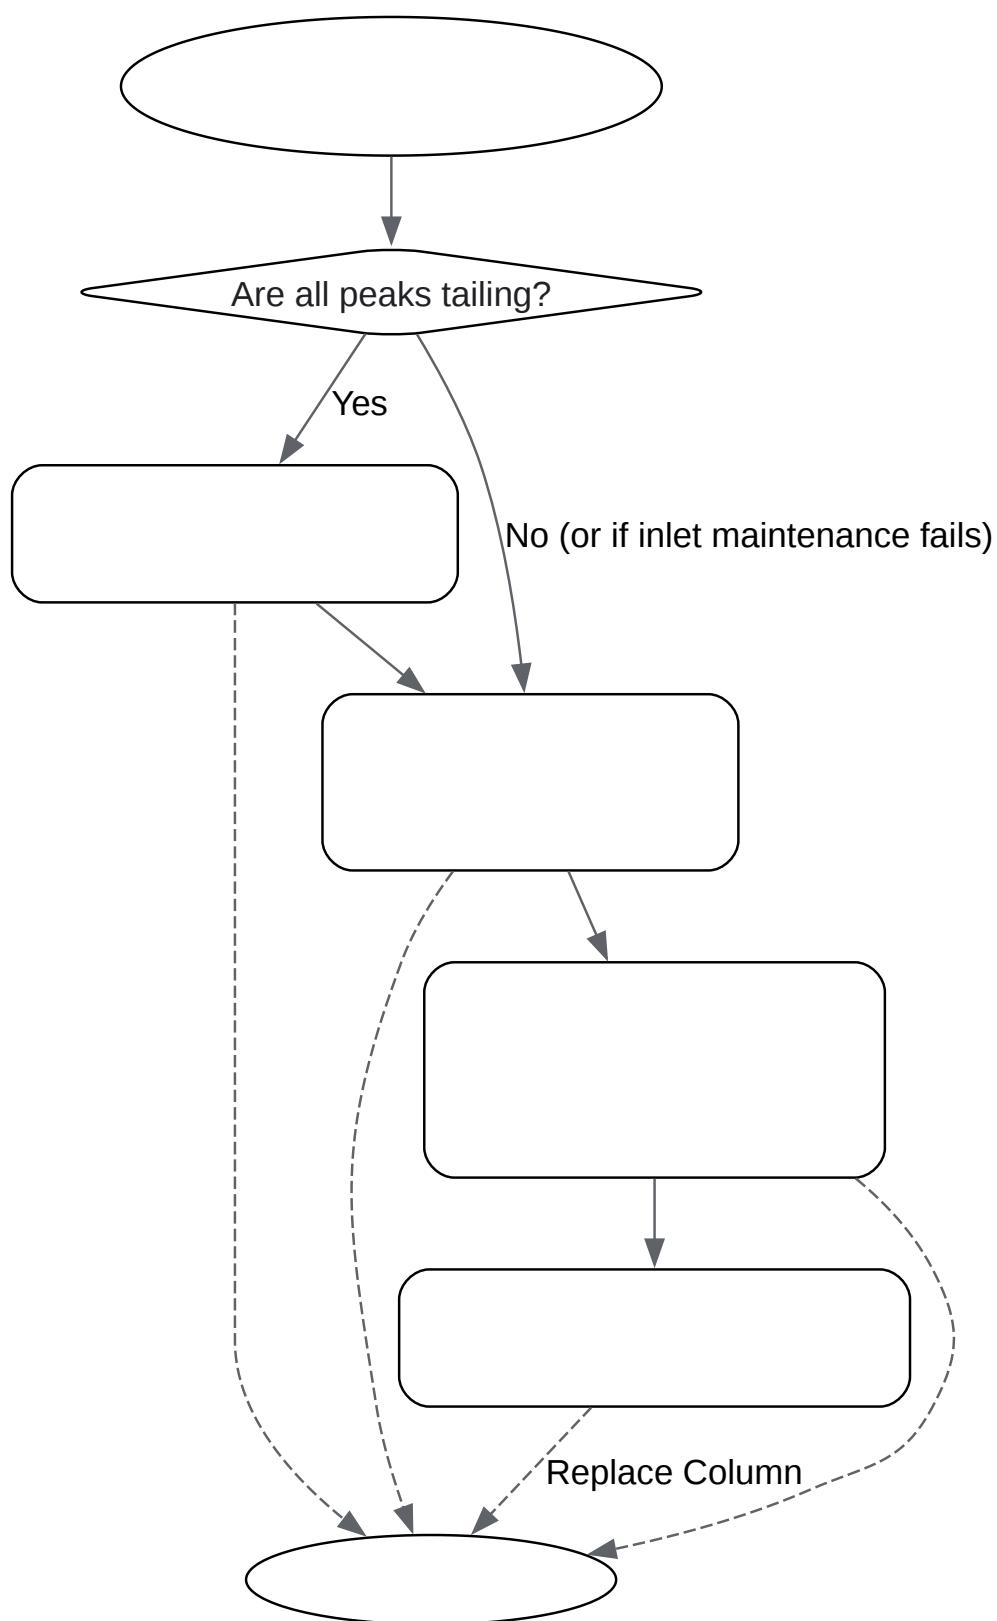
The following diagram illustrates a logical workflow for troubleshooting peak tailing with **n-Octylcyclohexane**.

Caption: A step-by-step workflow for diagnosing and resolving peak tailing in GC analysis.
