Troubleshooting Unexpected Triplin Gating Behavior: A Technical Support Guide

Author: BenchChem Technical Support Team. **Date:** December 2025

Compound Name: *Triplin*

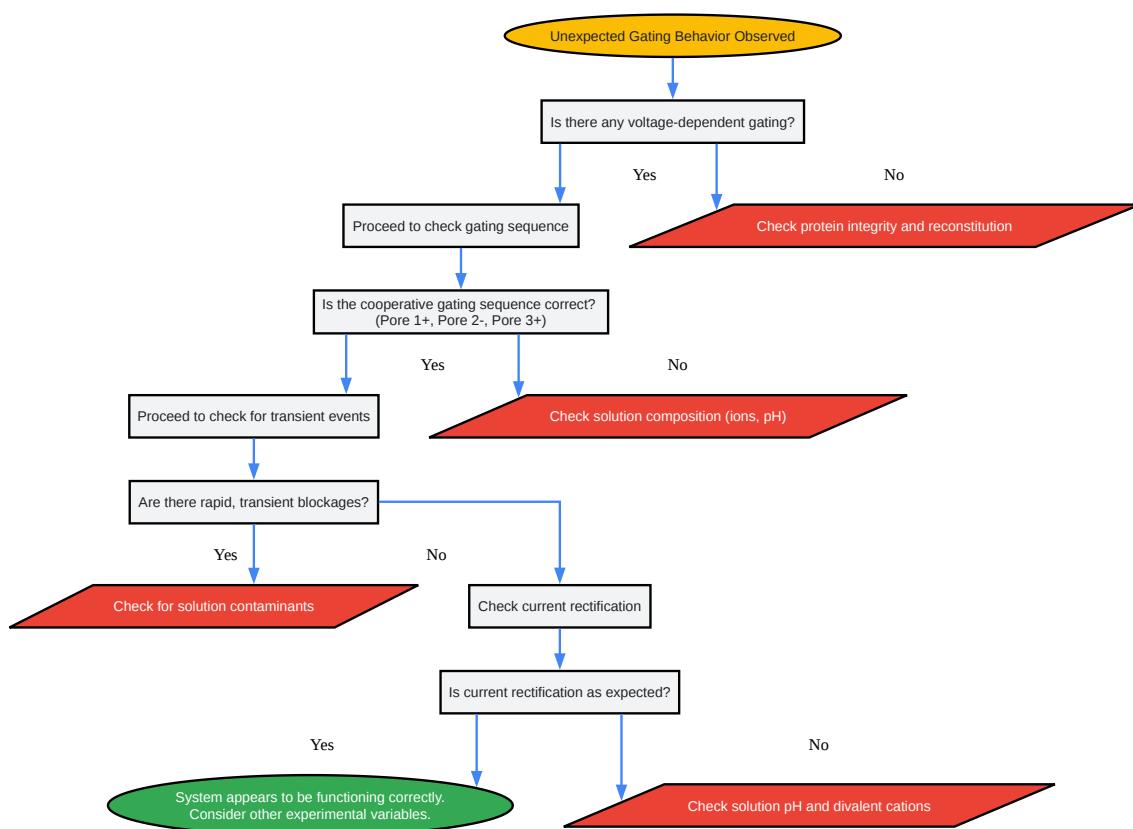
Caption: Troubleshooting workflow for unexpected **Triplin** gating.

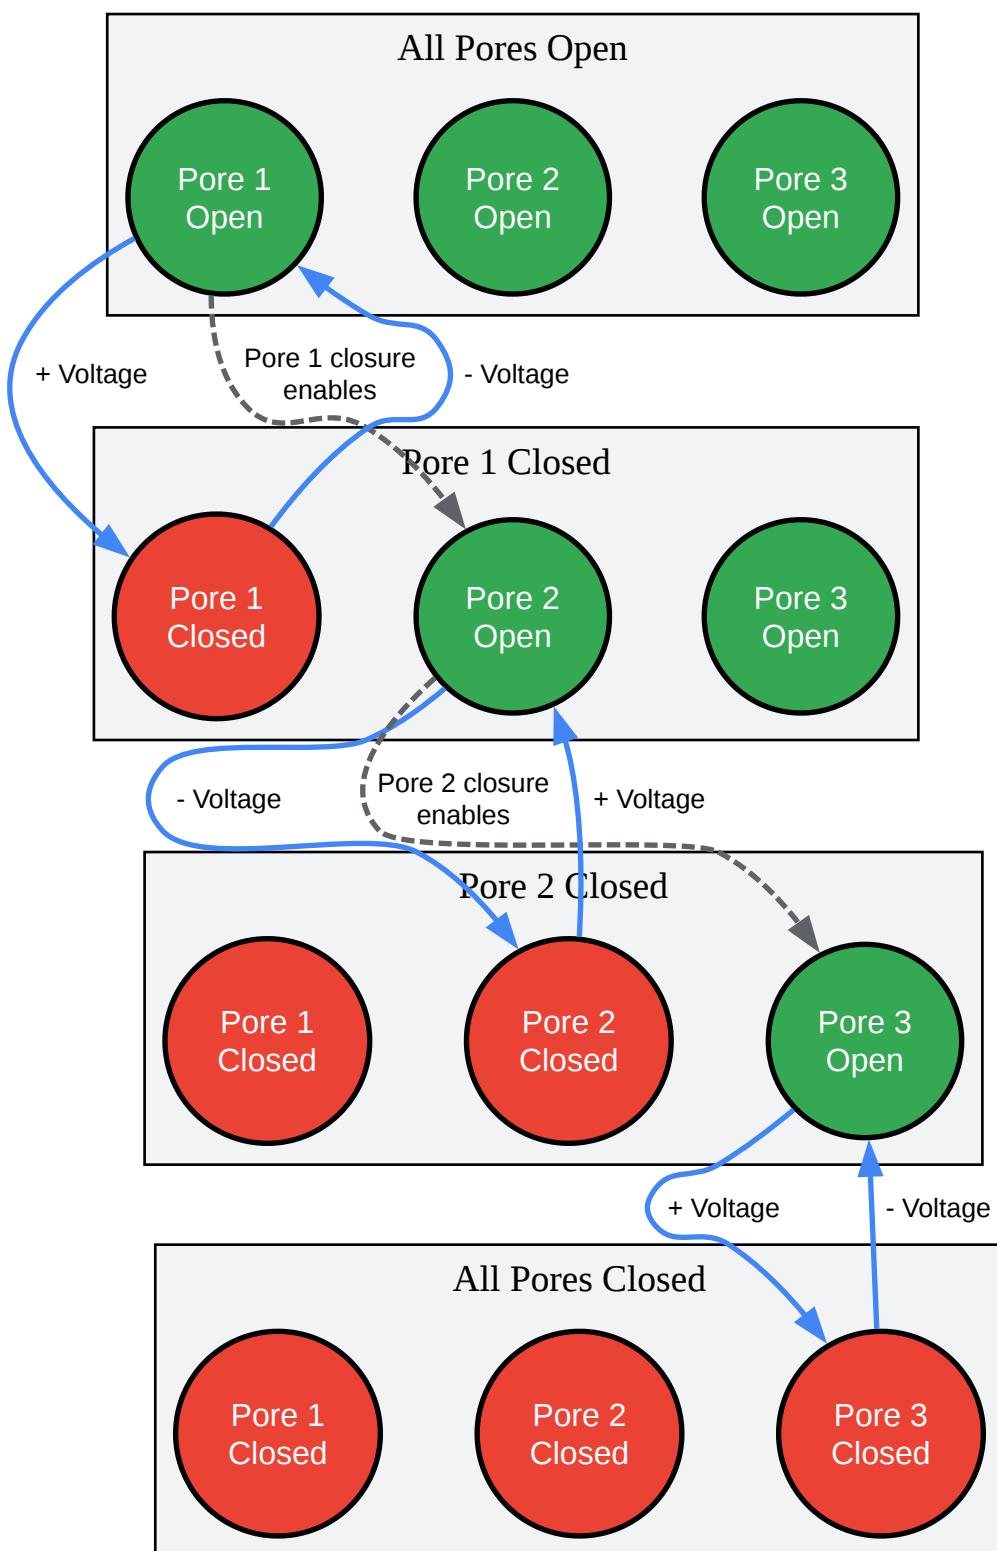
Caption: Cooperative gating pathway of the **Triplin** channel.

A2: **Triplin** exhibits a specific cooperative gating sequence where pore 1 closes first at positive potentials, followed by pore 2 at negative potentials, and finally pore 3 at positive potentials.[\[3\]](#)[\[4\]](#) A deviation from this sequence could indicate a problem with the experimental conditions. Check the ionic conditions and pH of your recording solutions, as these can influence the
