# Troubleshooting peak tailing in GC analysis of Methyl 2-hydroxyoctadecanoate

## Technical Support Center: GC Analysis of Methyl 2-hydroxyoctadecanoate

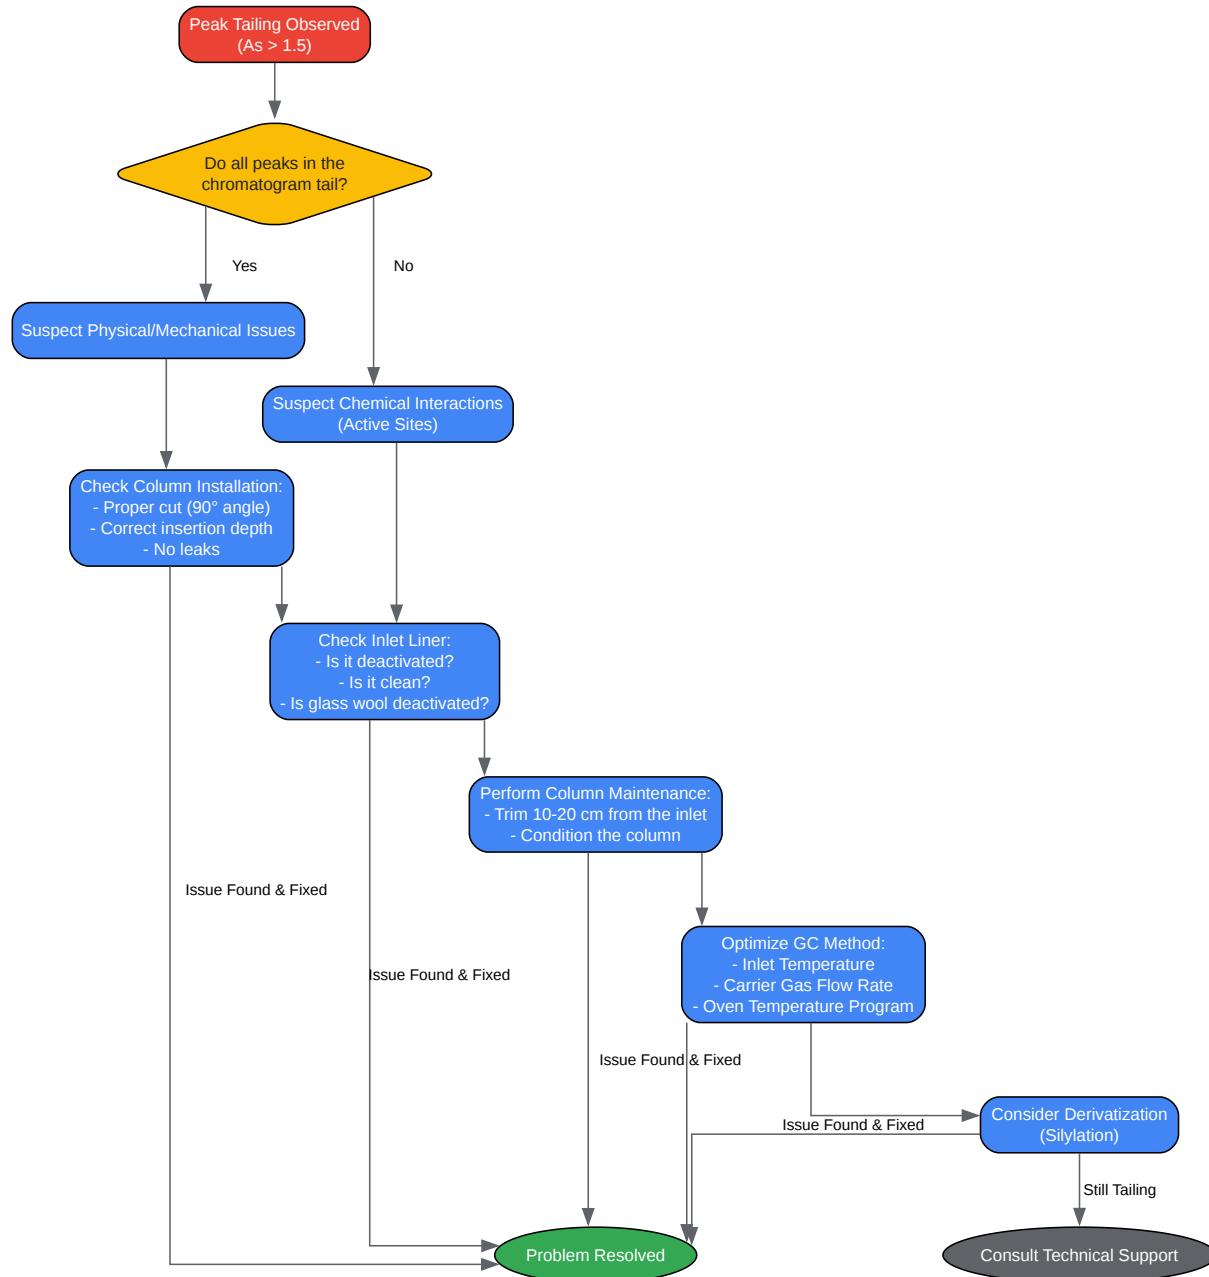
## Logical Troubleshooting Workflow

The following diagram illustrates a step-by-step workflow for troubleshooting peak tailing.
