# Panavia TC Technical Support Center: In Vitro Marginal Gap Formation

This technical support center provides researchers, scientists, and drug development professionals with a comprehensive guide to reducing marginal gap formation in vitro when using **Panavia TC** and other Panavia resin cements. The following troubleshooting guides and frequently asked questions (FAQs) are designed to address specific issues encountered during experimental setups.

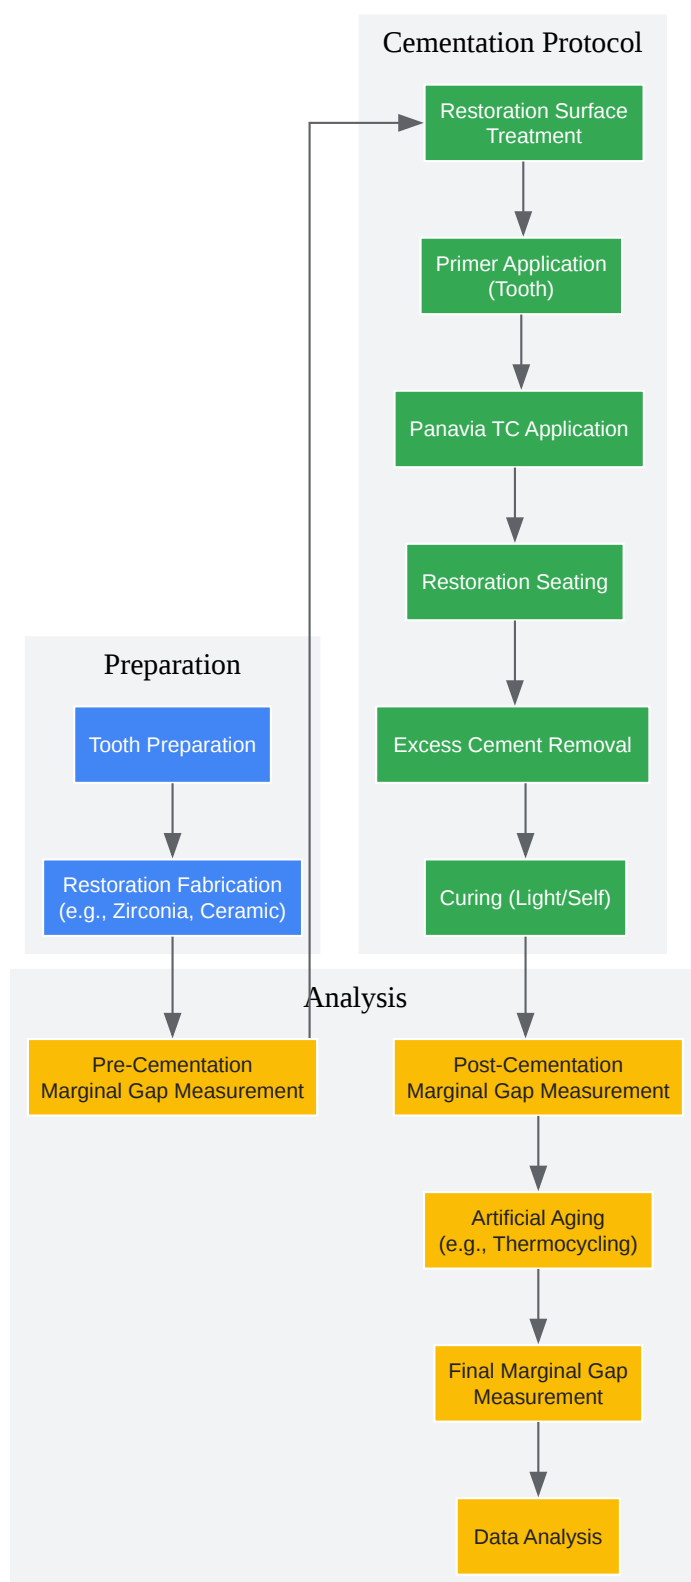
Caption: Experimental workflow for in vitro marginal gap measurement.

Protocol 1: Evaluation of Marginal Gap of Zirconia Frameworks Cemented with Panavia F2.0  
(Adapted from Papanas et al.)

- **Tooth Preparation:** Maxillary premolars are prepared with a rounded shoulder and a 6° convergence angle.
- **Framework Fabrication:** Zirconia frameworks are fabricated using a CAD/CAM system.
- **Pre-cementation Marginal Gap Measurement:** The marginal fit of the frameworks is evaluated under a microscope at 30x magnification before cementation.
- **Cementation:**
  - The internal surfaces of the zirconia frameworks are air-abraded.
  - For the Panavia F2.0 group, ED Primer II A and B are mixed and applied to the tooth surface for 30 seconds and then gently air-dried. Panavia F2.0 paste is mixed and applied to the framework.
  - The framework is seated with a constant load.

- Excess cement is removed, and the margins are light-cured.
- Post-cementation Marginal Gap Measurement: The marginal gap is re-evaluated under the microscope.
- Thermocycling: The cemented frameworks undergo 20,000 thermocycles.
- Final Marginal Gap Measurement: The marginal gap is measured again after thermocycling.

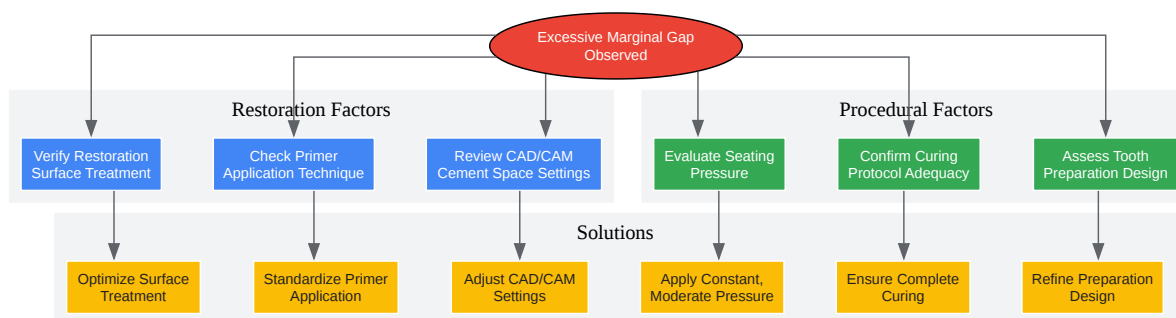
Caption: Troubleshooting logic for excessive marginal gap formation.

Issue: Excessive Marginal Gap Formation Observed with Zirconia Restorations

| Potential Cause | Troubleshooting Step | Expected Outcome |
| Inadequate Surface Treatment of Zirconia: The bond between Panavia and zirconia relies on proper surface conditioning. | Ensure zirconia restorations are air-abraded with alumina particles prior to cementation.<br><a href="#">[1]</a> | Improved micromechanical retention and a stronger bond, leading to a reduced marginal gap. |
| Improper Primer Application: The MDP monomer in Panavia primers is crucial for chemical bonding to zirconia.<br><a href="#">[1]</a> <a href="#">[2]</a> | Apply a thin, uniform layer of CLEARFIL™ CERAMIC PRIMER PLUS to the air-abraded zirconia surface and dry thoroughly with a mild air stream.<br><a href="#">[1]</a> | Enhanced chemical adhesion between the cement and the restoration, minimizing the gap. |
| Incorrect Cement Space Setting in CAD/CAM: The virtual cement space setting during the design phase can significantly impact the final fit. | For CAD/CAM fabricated zirconia crowns, consider the manufacturer's recommended cement space settings. One in vitro study found that different cement space settings can affect the marginal fit of resin-ceramic crowns.<br><a href="#">[3]</a> | An optimized cement space allows for a uniform cement layer without compromising the marginal seal. |
| Excessive Seating Pressure: While adequate pressure is necessary, excessive force can lead to thin spots in the cement layer and an increased marginal gap. | Apply a constant, moderate seating force during cementation. One study used a static load to seat crowns during cementation.<br><a href="#">[3]</a> | Consistent and complete seating of the restoration with a uniform cement layer, reducing the marginal gap. |
