# Technical Support Center: Troubleshooting Low Recovery of PCB 118-<sup>13</sup>C<sub>12</sub>

Compound Name: PCB118-13C12

Cat. No.: B15598500

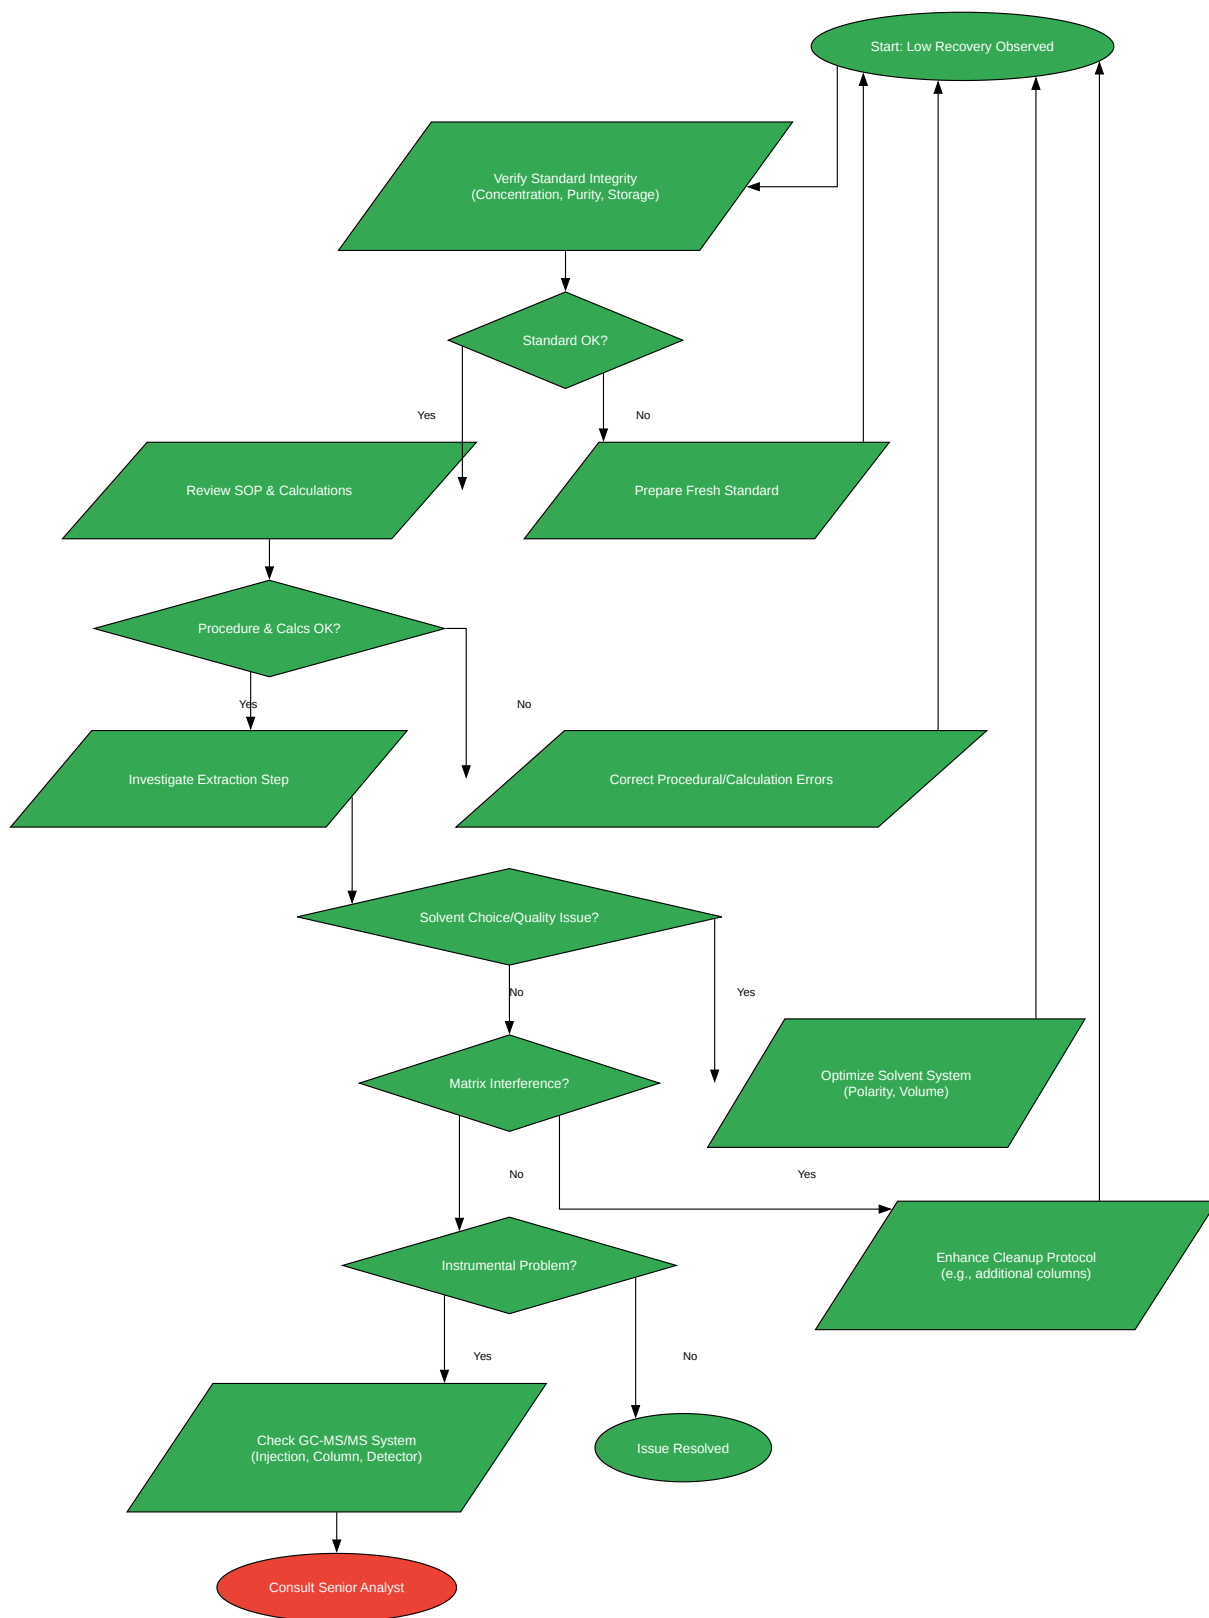
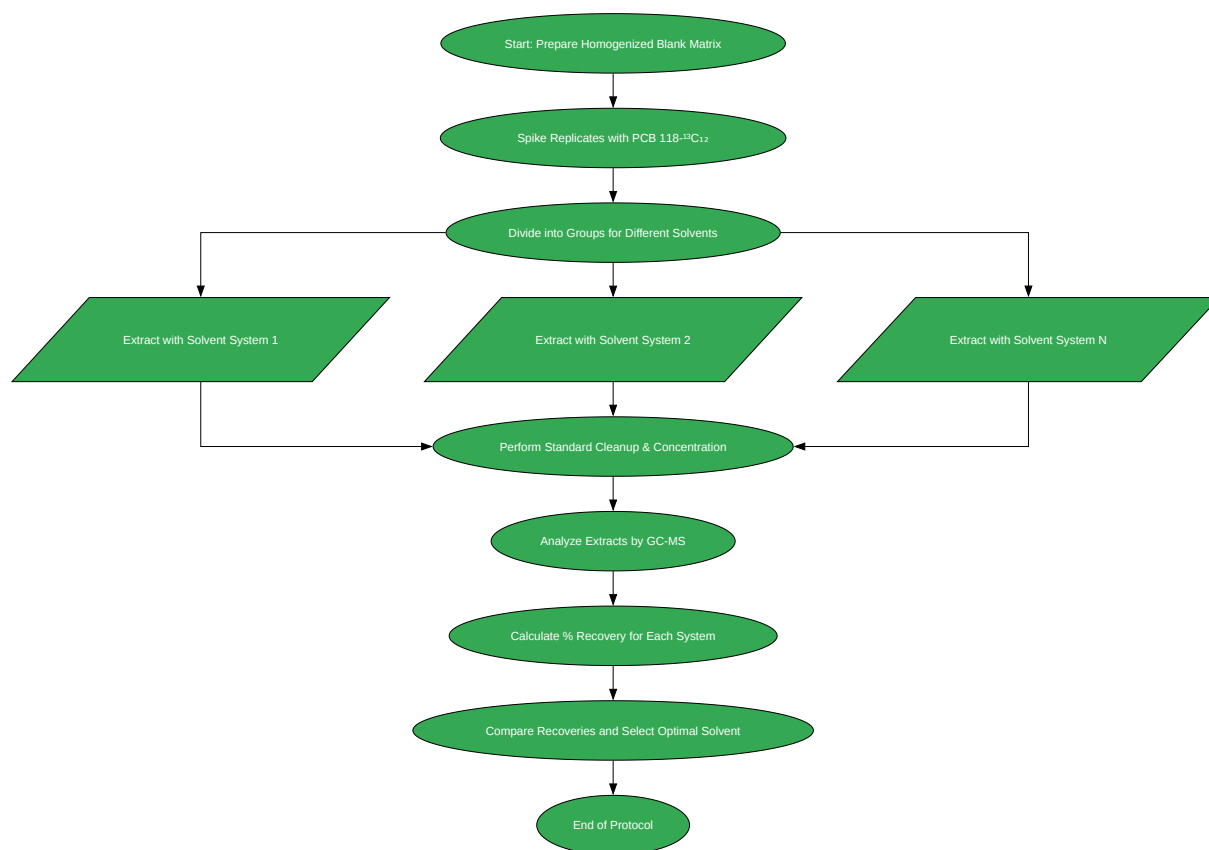
### Diagram: Troubleshooting Workflow for Low PCB 118-<sup>13</sup>C<sub>12</sub> Recovery

Low recovery of PCB 118-<sup>13</sup>C<sub>12</sub> can stem from various factors throughout the analytical process. This guide provides a systematic approach to identifying and resolving the root cause.
