Technical Support Center: Troubleshooting 3-Ethylnonane Peak Asymmetry in Gas Chromatography

Author: BenchChem Technical Support Team. **Date:** December 2025

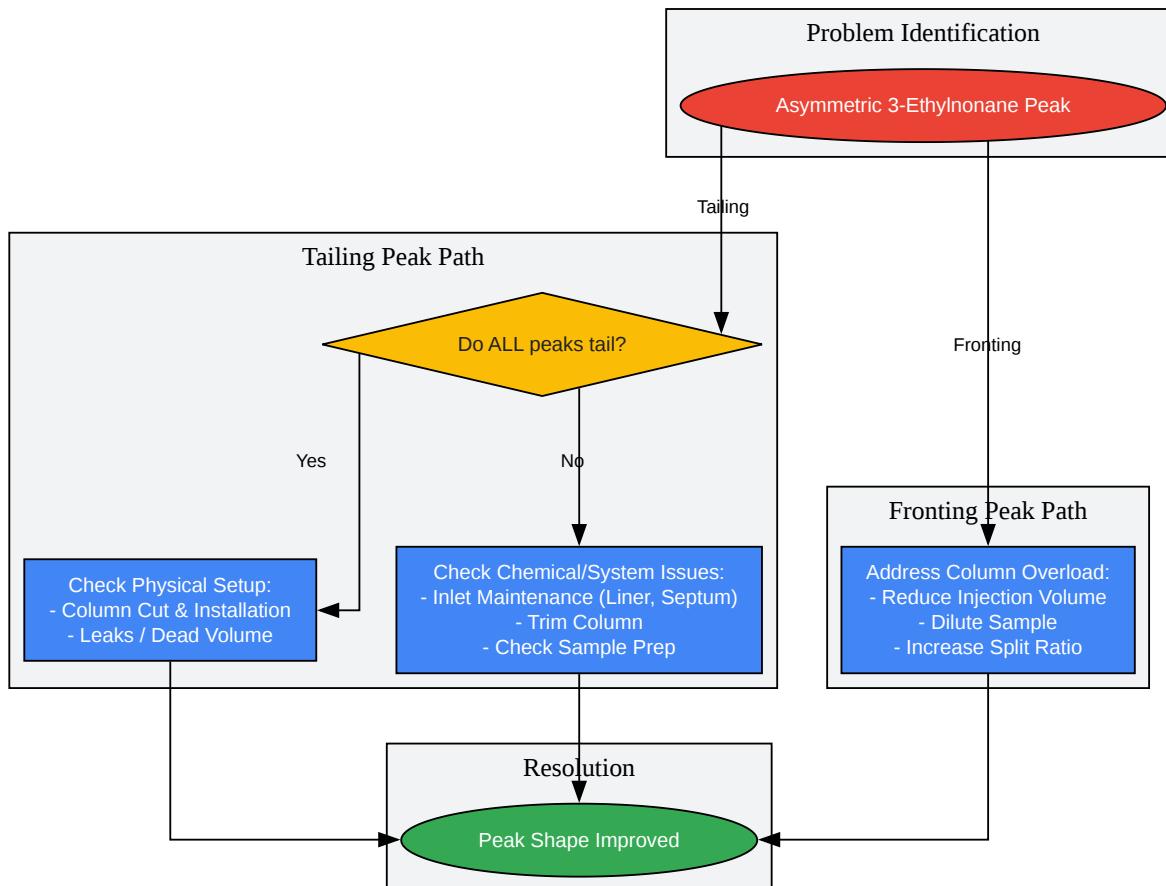
Systematic Troubleshooting Workflow

A logical workflow for troubleshooting peak asymmetry.

A systematic approach is the most effective way to troubleshoot chromatographic problems.

The following workflow and guides will help you isolate and resolve the cause of peak asymmetry.

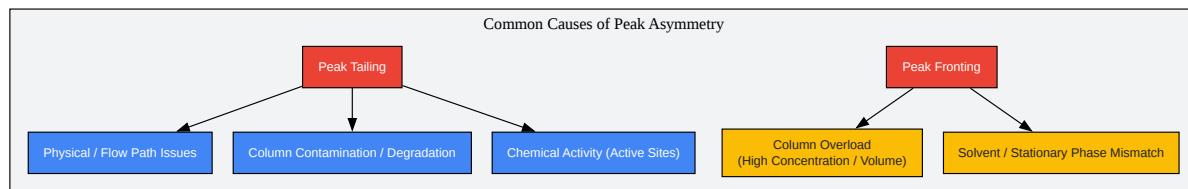
Visualization: Causes of Peak Asymmetry

The following diagram illustrates the primary causes of peak tailing and fronting.

Primary causes of peak tailing and fronting in GC.

- Peak Tailing: The latter half of the peak is broader than the front half. This can be caused by secondary, unwanted interactions between the analyte and the system or by physical disruptions in the sample path.[\[2\]\[3\]\[4\]](#)
- Peak Fronting: The first half of the peak is broader than the latter half. This is most commonly caused by overloading the column with too much sample.[\[2\]\[5\]\[6\]](#)
